SERVICE BULLETIN

Classification: HA16-004a	Reference: NTB16-112a	Date: July 12, 2017
------------------------------	--------------------------	------------------------

2013-2017 ALTIMA; A/C DOES NOT BLOW COLD AND CLUTCH DOES NOT ENGAGE

APPLIED VEHICLES: 2013-2017 Altima Sedan (L33)

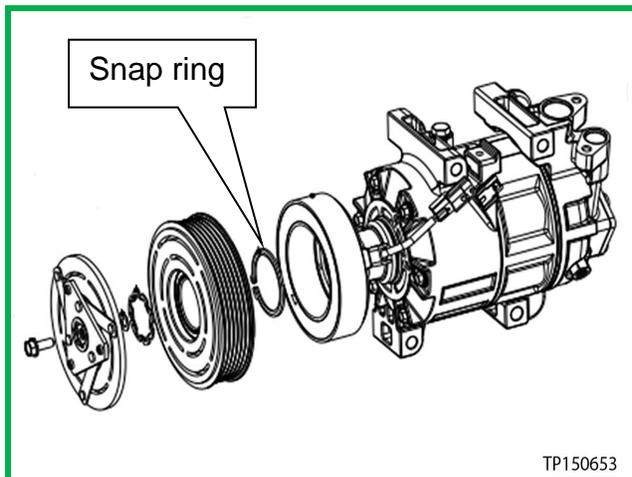
Figure 4

- The magnet coil for the applied vehicles is retained by a single snap ring as shown in Figure 4.
- Figure 5 (and illustrated in the ESM) is incorrect for the applied vehicles. The magnet coil is not attached by three bolts.

1. Replace the CLUTCH COIL ASSY-COMPRESSOR (magnet coil).
 - Refer to the Electronic Service manual (ESM), section **HA – Heater & Air Conditioning System** for replacement information.
 - See page 2 for required tools.
