SERVICE BULLETIN

Classification: BT17-009	Reference: NTB17-074	Date: July 10, 2017
-----------------------------	-------------------------	------------------------

2016-2017 MAXIMA; RUST AROUND REAR LICENSE LAMP FINISHER

APPLIED VEHICLE: 2016-2017 Maxima (A36)

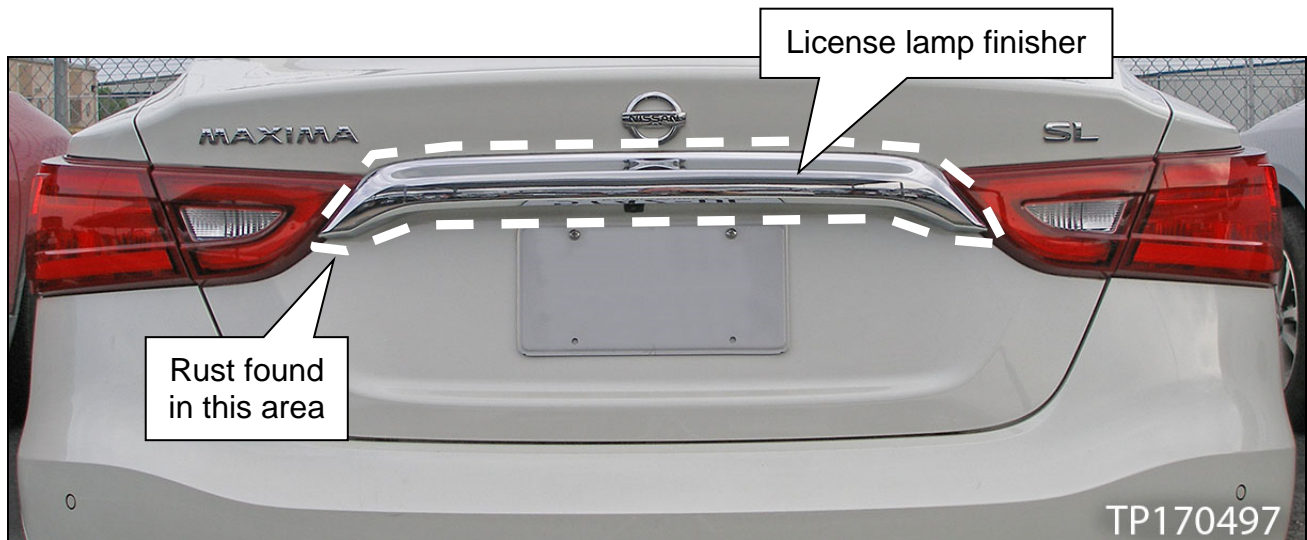
Figure 1

When rust is found on the rear deck lid surface in the area surrounding the license lamp finisher (Figure 1), or when replacing the license lamp finisher for any reason.

- Replace the license lamp finisher with the new replacement part listed in **PARTS INFORMATION**.
 - Refer to the Electronic Service Manual (ESM), section **EXT – Exterior**, for removal and installation information.
- Repair any damaged surfaces that were in direct contact with the license lamp finisher.
