# SERVICE CAMPAIGN BULLETIN

NTB17-075

## VOLUNTARY SERVICE CAMPAIGN 2017 TITAN AND TITAN XD; BED RAIL REPAIR

**CAMPAIGN ID #:** PC577  
**APPLIED VEHICLE:** 2017 Titan (A61)  
2017 Titan XD (A61)

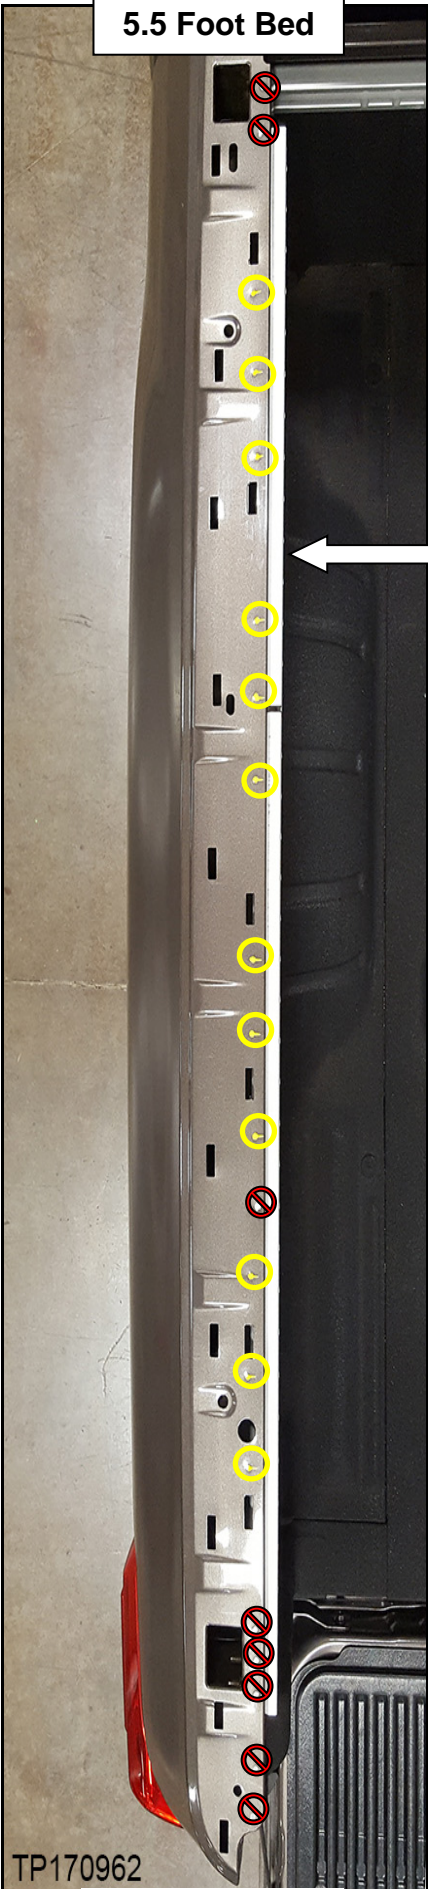
Figure 8

5.5 Foot Bed

5.5 foot bed will require 12 rivets per side (24 rivets total).

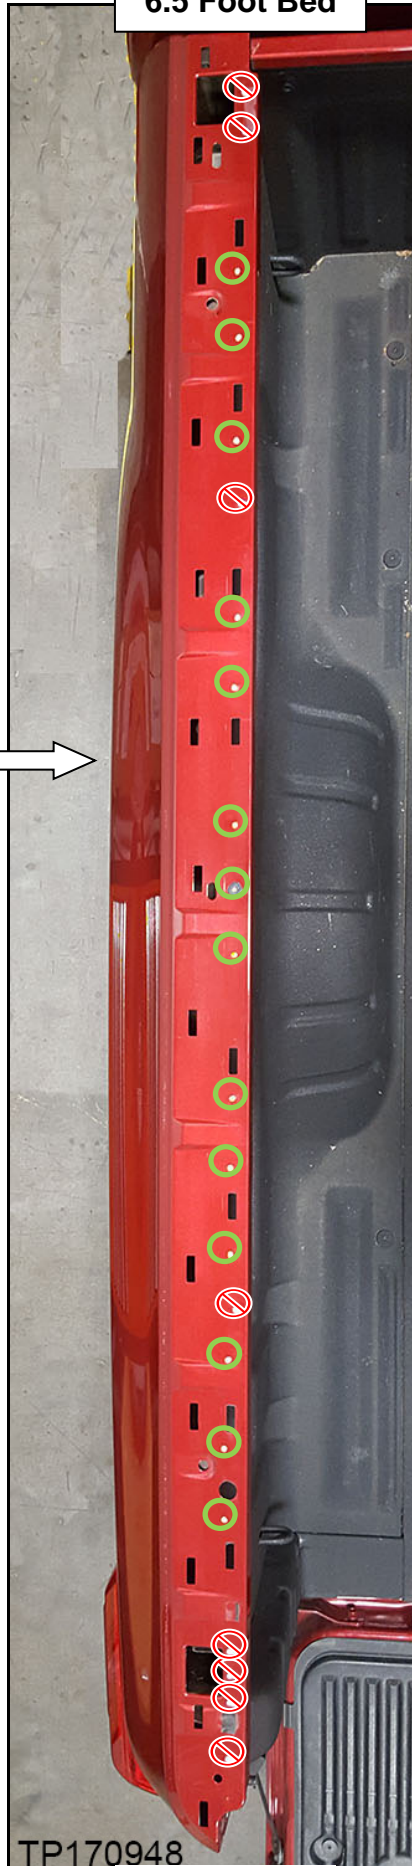
Figure 9

6.5 Foot Bed

Left side is shown; right side is the same.

6.5 foot bed will require 14 rivets per side (28 rivets total).

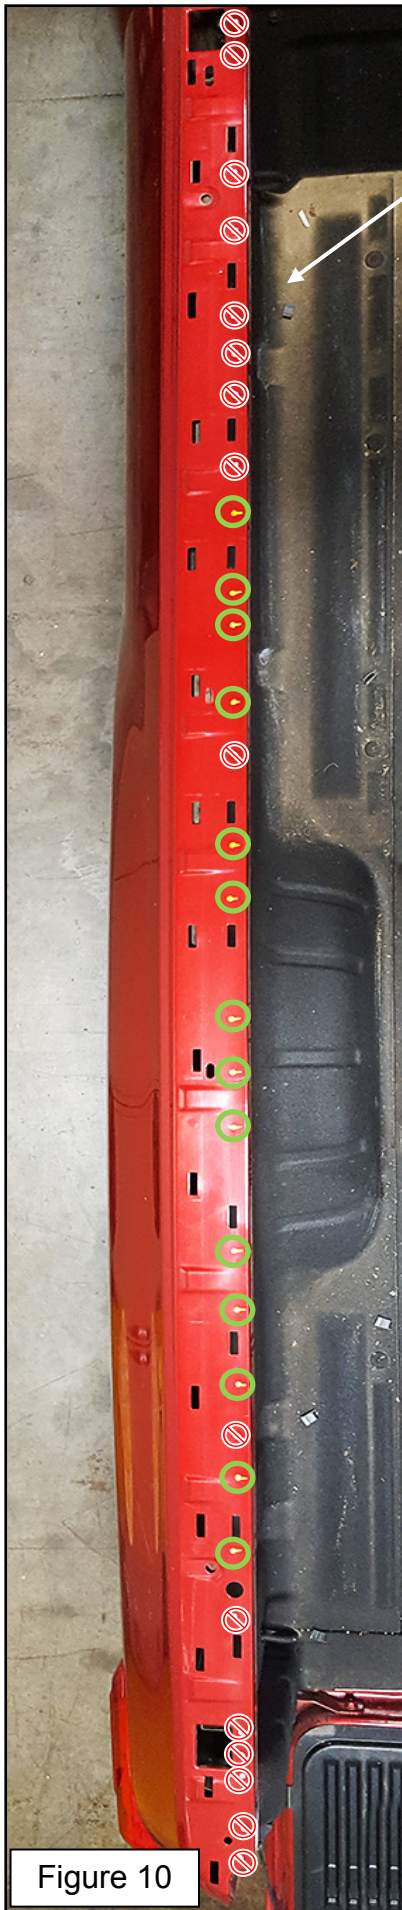
Figure 10

**8 Foot Bed**

Left side requires 14 rivets.  
 Right side requires 9 rivets.  
 8 foot bed will require 23 rivets total.
