# SERVICE BULLETIN

Classification: EL17-024	Reference: NTB17-067	Date: August 16, 2017
-----------------------------	-------------------------	--------------------------

## 2016-2017 MURANO; PHONE WILL NOT CONNECT WITH VEHICLE AND BLUETOOTH® AND PHONE BUTTONS ARE GRAYED OUT IN SETTINGS MENU

**APPLIED VEHICLES:** 2016-2017 Murano (Z52)  
2016 Murano Hybrid (Z52)

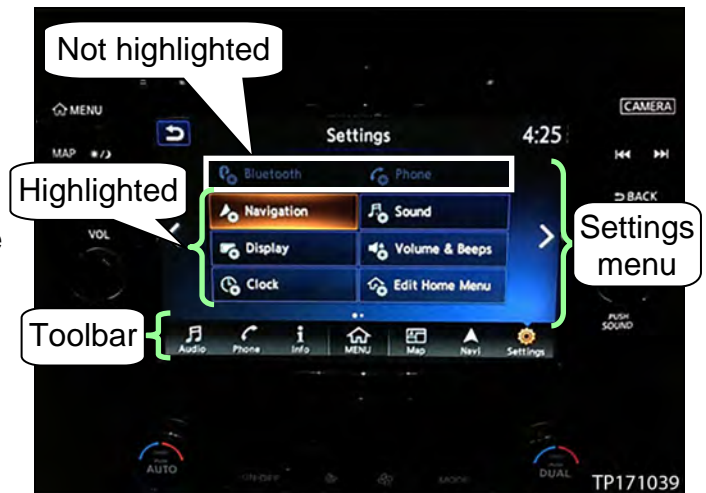
Figure A

- When the incident occurs, the “Bluetooth” and “Phone” buttons in the settings menu of the multi AV display are grayed out (not highlighted) and do not respond when pressed.
- When pressing the “Phone” button in the toolbar or on steering wheel, the message “Please wait..” displays.
- The incident may be intermittent.

Update the Navigation system software using the SD card shown on page 2 and the **SERVICE PROCEDURE** beginning on page 3.
