SERVICE BULLETIN

Classification: EC16-034a	Reference: NTB17-082a	Date: August 21, 2017
------------------------------	--------------------------	--------------------------

NISSAN; DTC P0456 CAUSED BY EVAP LEAK AT VENT CONTROL VALVE O-RING

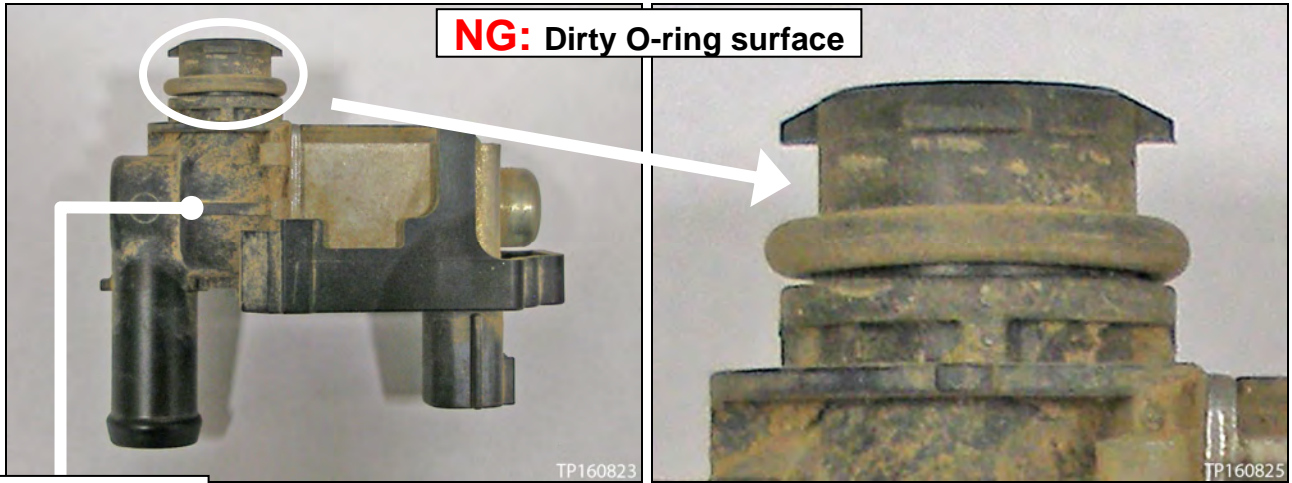
Vent control valve

1. Replace the O-ring.
 - To access the O-ring, refer to the appropriate section in the Electronic Service Manual (ESM) of the **APPLIED VEHICLE** for vent control valve removal and installation.
 - This O-ring is now available separately (see **PARTS INFORMATION**).
 - When installing, do not add any lubrication to the O-ring.
 - Seat the O-ring all the way down as shown on page 4, Figure 7.
 - Having the O-ring seated all the way down will assure it is not twisted or rolled over.
 - Refer to the pictures on pages 3 and 4 for additional installation information.

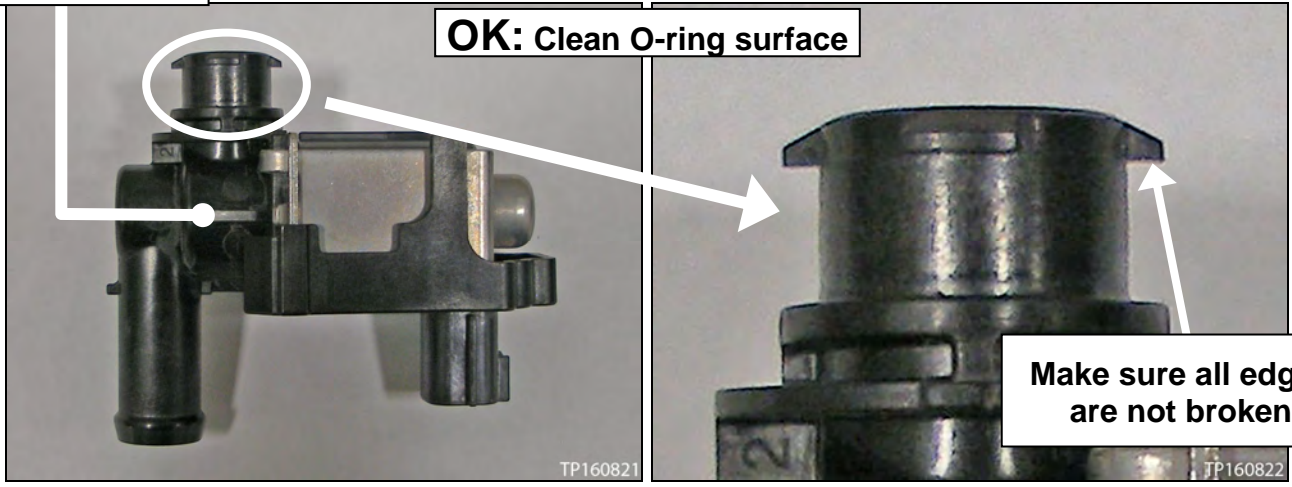
Where vent control valve mounts in canister

Canister

This surface must be clean all around

- Make sure the surfaces that the O-ring comes in contact with are clean.
- When installed, make sure the O-ring is not twisted or rolled over.
- Verify the repair is complete by checking for leaks with a “smoke” leak detection machine or CONSULT-III plus (C-III plus).
 - If a “smoke” leak detection machine is used, follow the manufacturer’s operating instructions.
 - If C-III plus is used:
 1. Confirm the fuel filler cap is secure.
 2. Connect Essential Tool J-42909 to the EVAP service port.
 3. Using Active Test, close the vent control valve.
 4. Apply pressure using J-42909 until the bar graph reaches about halfway.
 5. Monitor the bar graph for 10 minutes.
