Clicking At The Rear Wheels During Hard Corning Maneuvers

Vehicle Type: **918 Spyder**

Model Year: **2015**

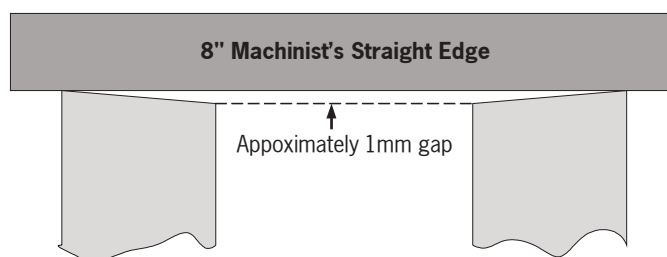
Figure 1

3. Re-installed brake rotors using new M6 screws. Torque: 8Nm
4. Re-installed brake calipers using new M10 nuts. Torque: 65Nm
5. Using a 8" machinist straightedge, verify that the mating surface of the wheels are tapered slightly (approximately 1mm) from the outside to the inside (see Figure 1). Report any issues to the Technical Hotline.
