N069NAS1

TECHNICAL BULLETIN

502-00: Uni-Body, Subframe and Mounting System

Service Action: Rear Wheel Arch Blanking Seals Not Installed

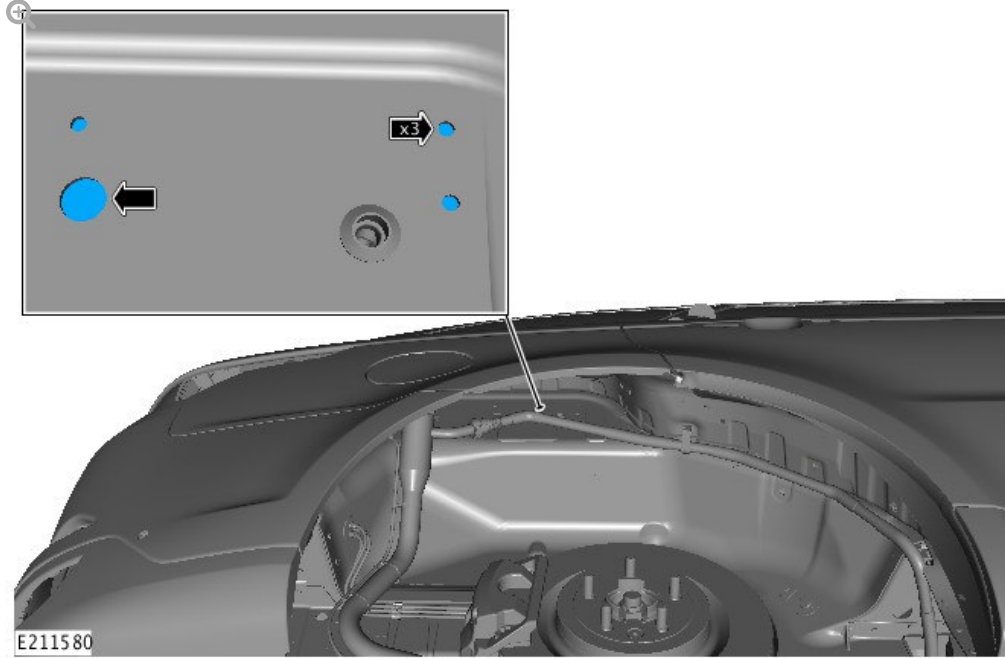
2

Locate the 4 holes.

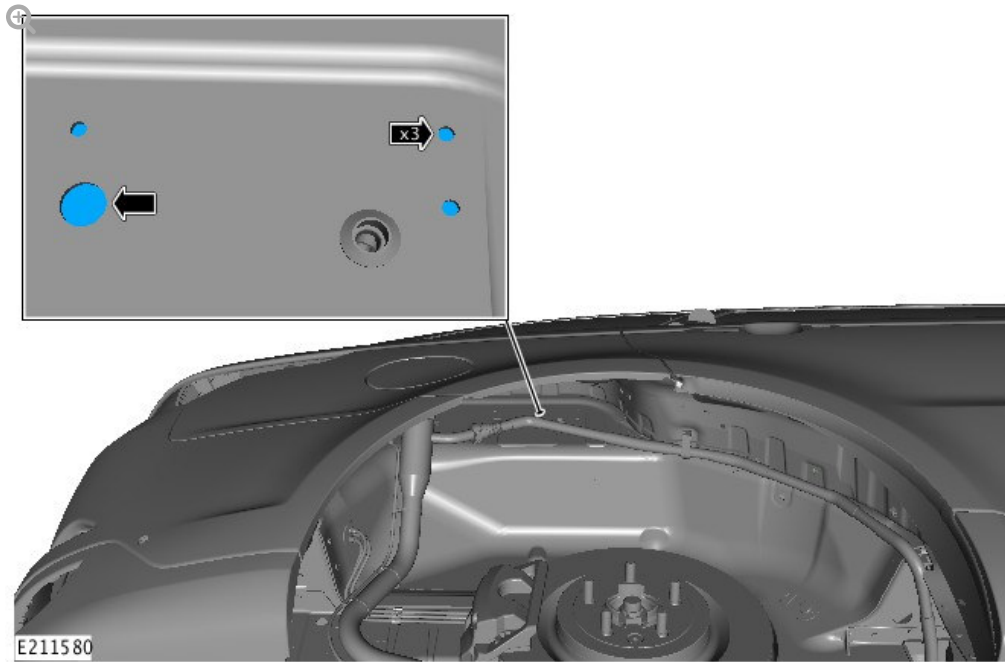
3

Inspect the 4 holes for blanking seals.

- If blanking seals are installed in all 4 holes, go to Step 5.
- If blanking seals are not installed in 1 or more holes, go to Step 4.
