N060 UPS5017-1BNAS1

# TECHNICAL BULLETIN

501-05: Interior Trim and Ornamentation

Update Prior to Sale: Deployable Luggage Compartment Floor Ball Spigot

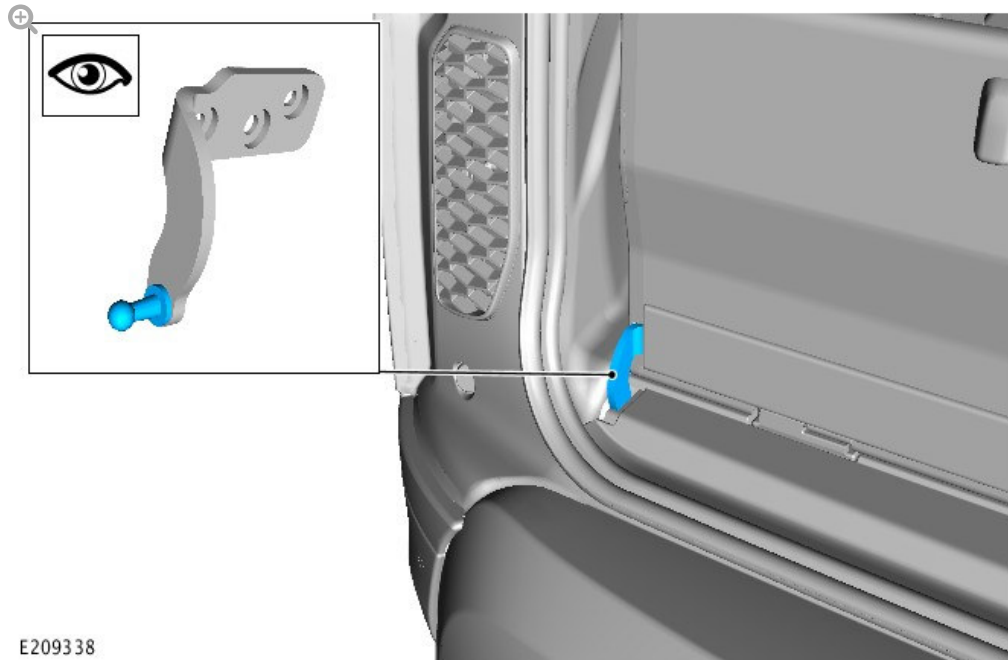
E209338

Deployable luggage compartment floor operating arm location.

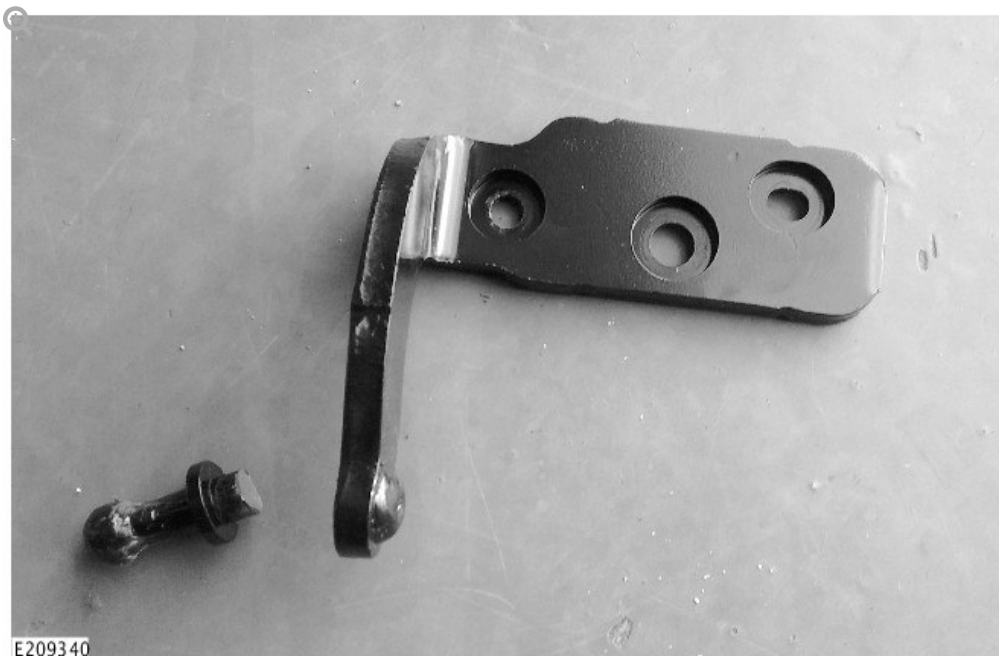
Failed condition shown; the deployable luggage compartment floor operating arm may not have failed upon inspection.

Example: damage to the deployable luggage compartment floor operating arm.
