Technical Service Bulletin

55 Intermittently unable to open trunk lid with foot motion activation

55 17 40 2045651/2 January 11, 2017. Supersedes Technical Service Bulletin Group 55 number 16-39 dated October 14, 2016 for reasons listed below.

Model(s)	Year	VIN Range	Vehicle-Specific Equipment
A4	2017	A056777 - A079742	Audi advanced key
A4	2017	N032011 - N041226	Audi advanced key

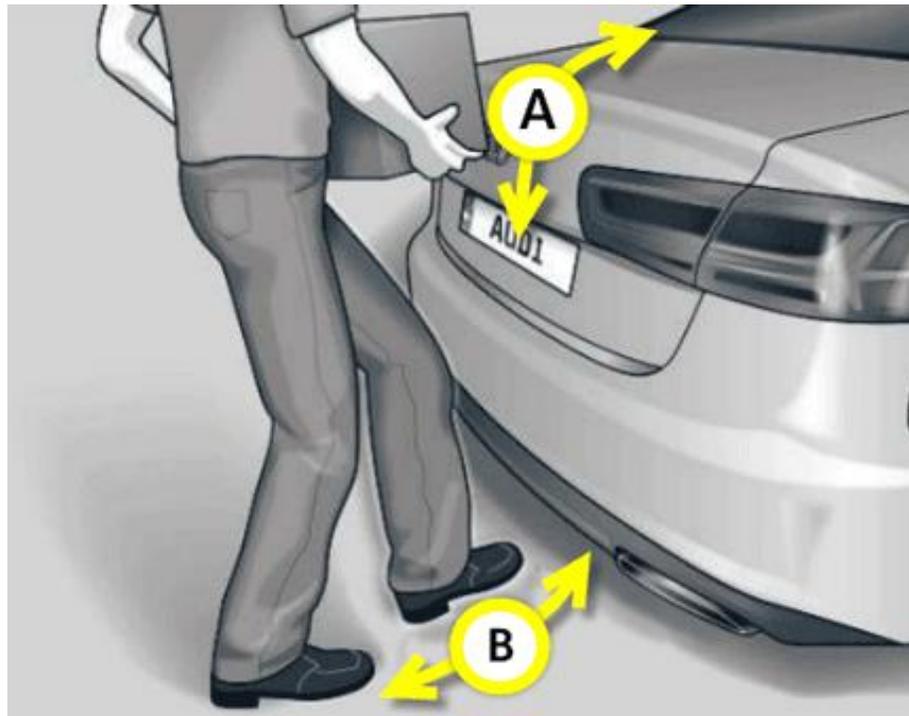
1. Verify the customer complaint by following the steps below:
 - Lock the vehicle and wait 10 minutes so the CAN bus goes to sleep
 - Verify the opening of the trunk lid is inoperative when using the foot motion activation (Figure 1)
 - Press the unlock button on the remote key
 - Verify the opening of the trunk lid is now operational when using the foot motion activation (Figure 1)

Figure 1. To activate the opening of the trunk lid with foot motion activation make sure you have the vehicle key with you, ignition off. Stand approximately 8" from the rear bumper cover. Move foot back and forth below the rear bumper cover (B). Trunk lid will open once the sensor has detected movement (A).

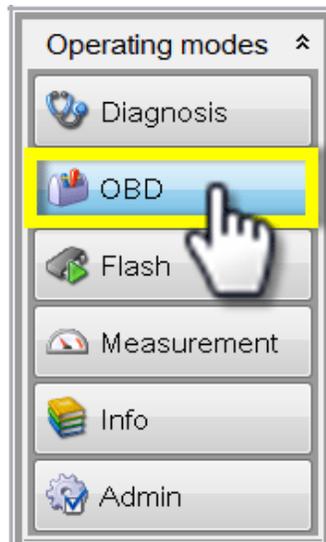
- Check the production date of the Power Rear Lid Control Sensor J938 (address word 0082):
 - In ODIS, select the “OBD” operating mode (Figure 2)

Figure 2. Select “OBD” operating mode in ODIS.

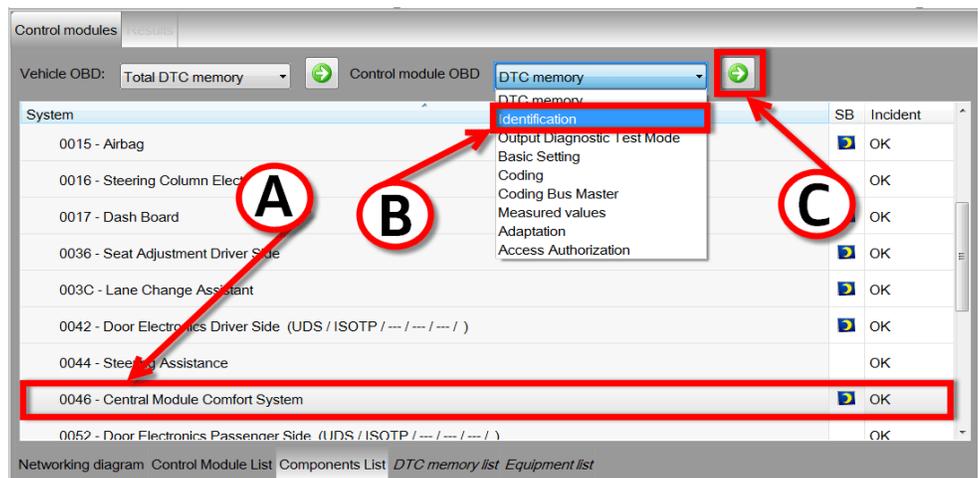
Select the Central Module Comfort System (address word 0046) (Figure 3A):

- Then select Identification mode via the Control Module OBD drop down selection list (Figure 3B)
- Finally click the Control module OBD right arrow button to enter the identification menu (Figure 3C)
- This will bring up the Results tab in ODIS

Figure 3. Select the Central Module Comfort System (address 0046) (A). Then select Identification mode via the Control Module OBD drop down selection list (B). Finally click the Control module OBD right arrow button (C) to enter the identification menu.

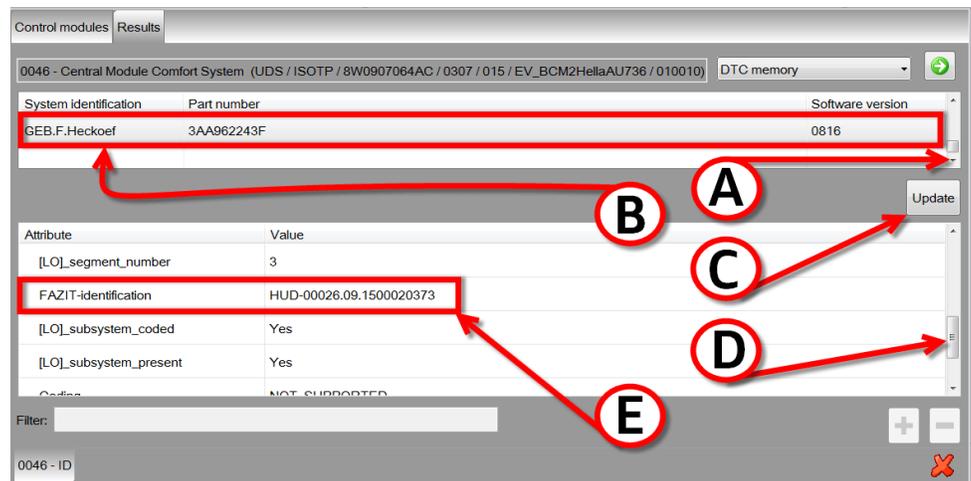
- In the upper scroll box of the Results tab, use the scroll bar (Figure 4A) to scroll down to “GEB.F.Heckoef”
- Select “GEB.F.Heckoef” (Figure 4B)
- Click “Update” (Figure 4C) to display the identification information for the Power Rear Lid Control Sensor J938 (address word 0082)

- In the lower scroll box of the Results tab, use the scroll bar (Figure 4D) to scroll down to the FAZIT-identification value (Figure 4E)

Figure 4. In the upper scroll box of the Results tab, use the scroll bar (A) to scroll down to “GEB.F.Heckoeff”. Select “GEB.F.Heckoeff” (B). Click “Update” (C) to display the identification information for the Power Rear Lid Control Sensor J938 (address word 0082). In the lower scroll box of the Results tab, use the scroll bar (D) to scroll down to the FAZIT-identification value (E).
