Technical Service Bulletin

68 Parking aid malfunctions

68 17 20 2043850/3 January 11, 2017. Supersedes Technical Service Bulletin Group 68 number 16-19 dated December 12, 2016 for reasons listed below.

Model(s)	Year	VIN Range	Vehicle-Specific Equipment
Q7	2017	All	Not Applicable

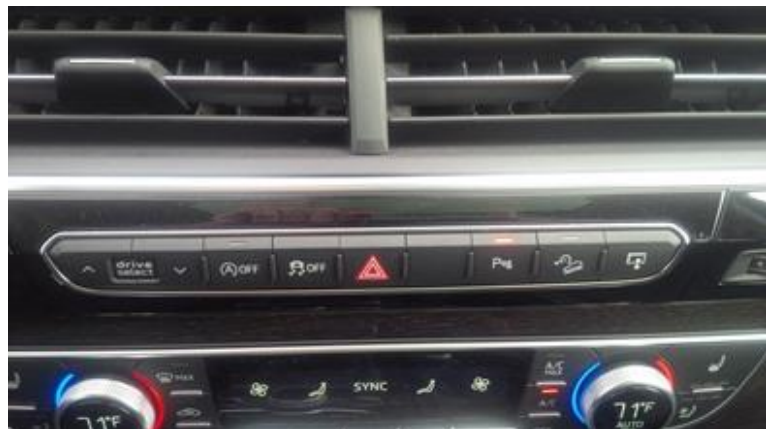
- The LED on the Park Assist button is flashing to indicate an error with the system, and an error message is displayed on the DIS (Figure 1 and Figure 2).
- Other symptoms may include loss of courtesy lamp operation or loss of glovebox illumination.
- Fuse ST5 SB15 may be blown (Figure 3).

Figure 1. LED on Park Assist button E266.

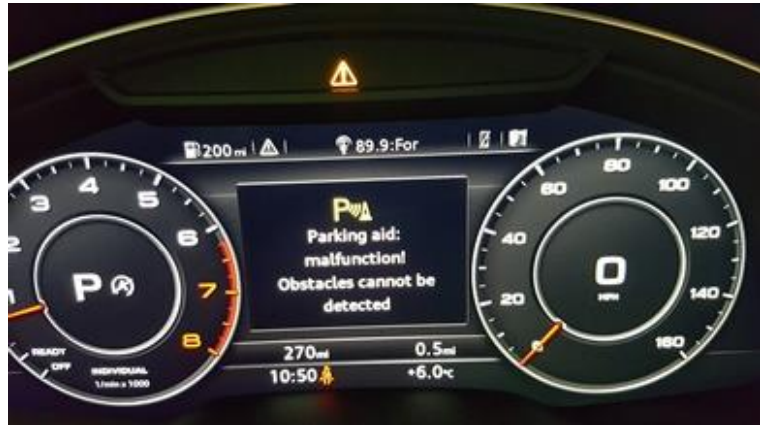
Figure 2. Error on the DIS that appears for the customer.

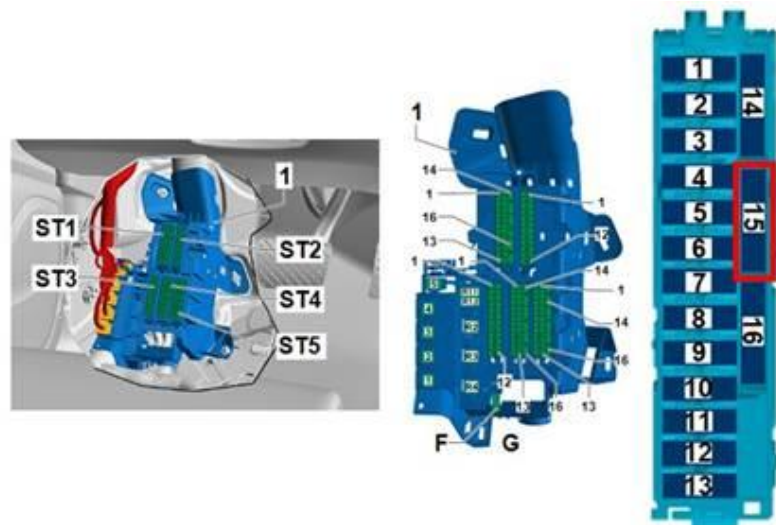
Figure 3. Fuse location.

- If the wiring in the visor is damaged, replace the sunvisor (Figure 4).
- If the wiring in the roof harness is damaged, it can be repaired using the VAS 1978B (Figure 5).
- If fuse ST5 SB15 is found to be blown, replace it.

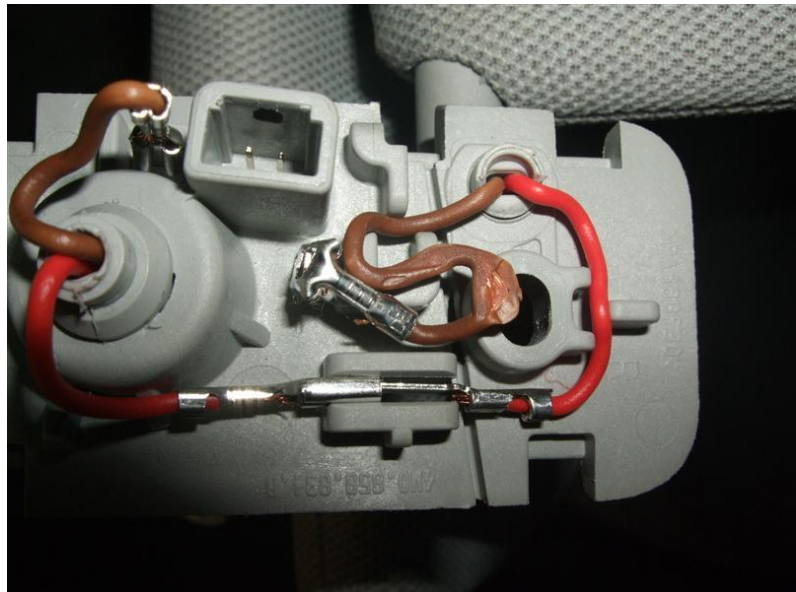
The sunvisor wiring or the wiring in the roof leading to one or both sunvisors is damaged (shorted to B+, shorted to ground or open) due to the wiring routing or damage from the sunvisor mounting screw.

Figure 4. Sunvisor wiring damage typically found after visor removal and inspection.

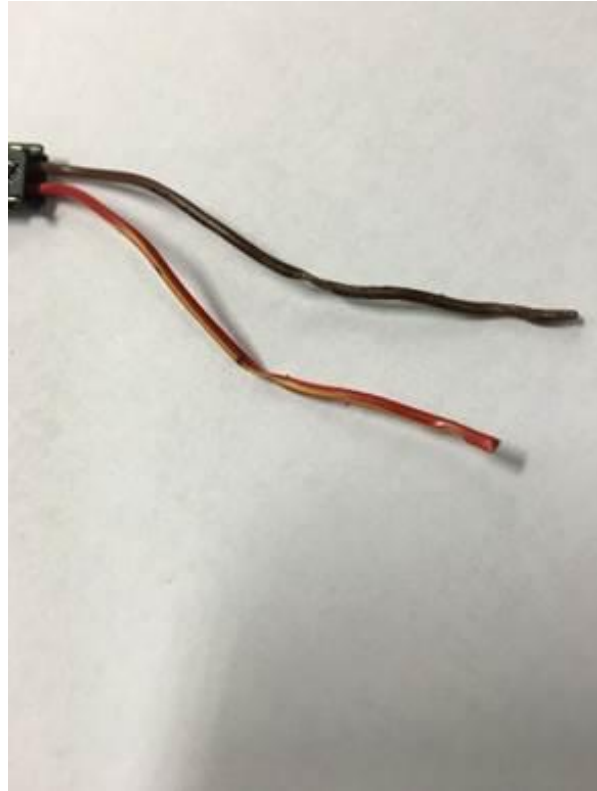
Figure 5. Damage typically found on roof harness.
