# Technical Service Bulletin

## 87 Faint noise heard in cabin from air conditioning circuit

87 17 80 2044717/3 January 26, 2017. Supersedes Technical Service Bulletin Group 87 number 16-77 dated September 19, 2016 for reasons listed below.

Model(s)	Year	VIN Range	Vehicle-Specific Equipment
A6, A7	2012 - 2015	All	2.0L or 3.0L gas engine

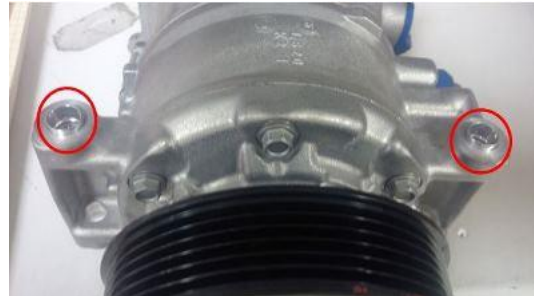
It is imperative that the compressor mounting bolt centering sleeves be reinstalled with the compressor (Figure 3). Failure to reinstall these sleeves will result in compressor failure (as well as possible engine and/or ancillary component damage) in a short period of time. If any sleeves were misplaced during the removal and reinstallation process, new sleeves should be ordered and installed on the compressor housing before reassembly. Compressor or consequential component damage resulting from a failure to install the centering sleeves will not be accepted under warranty.

**Figure 3.** Mounting bolt centering sleeves on the air conditioning compressor housing.

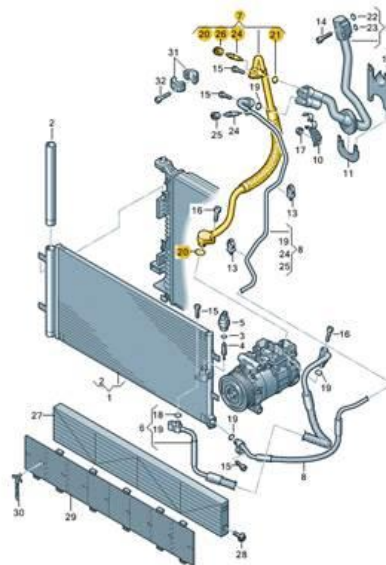
**Figure 4.** Low side line to be replaced.

3. Replace the low side refrigerant line that connects the air conditioning compressor suction port to the hybrid refrigerant line to the expansion valve (Figure 4). Be certain to use new O-rings at these and all refrigerant circuit joints that are disconnected.

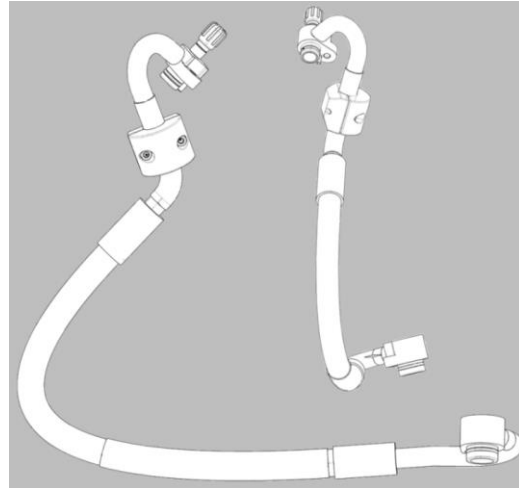
**Figure 5.** Balance weight position on low side line.

4. Install the balance weight (part number 4G0513621A) to the line in the position shown in the illustration (Figure 5).
