#### 91 Rearview camera intermittently inoperative (DTC 2203)

91 17 00 2041430/4 January 11, 2017. Supersedes Technical Service Bulletin Group 91 number 16-48 dated June 23, 2016 for reasons listed below.

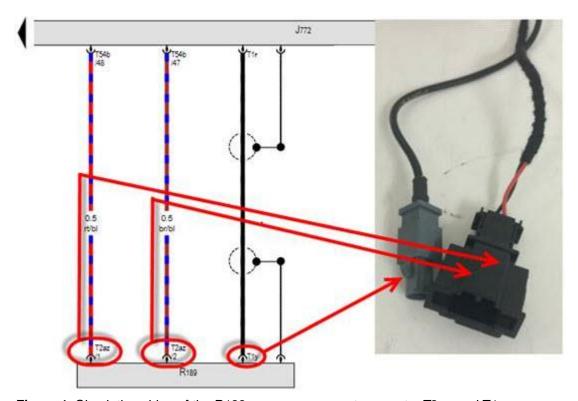
Figure 1. Check the wiring of the R189 reverse camera at connector T2az and T1y.

- Before proceeding, confirm that the DTC and one of the fault symptoms listed in the Condition are logged in the rearview camera system control module, J772 (address word 006C). If the DTC is not listed with one of the fault symptoms, this bulletin does not apply.
- 2. Check the wiring of the R189 reverse camera at connector T2az and T1y (Figure 1). Repair any loose connectors or pins, corrosion, or any other physical damage.

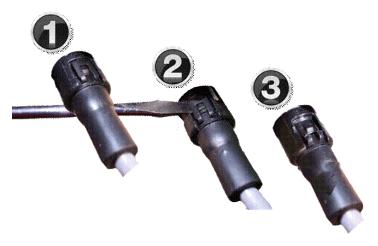
**Figure 3.** Locate locking tab (1), lift up on tab with screwdriver (2), snap tab off (3).

- 4. Remove the original harness from the reverse camera (Figure 3):
  - First, locate the locking tab on the reverse camera harness.
  - Next, using a small flat head screw driver, lift up on the locking tab.
  - Finally, snap the old locking tab off the defective harness to prevent reuse.
