Technical Service Bulletin

91 MIB1 Audi connect and Online Services Inoperative with SIM not recognized

91 17 05 2045723/2 January 26, 2017. Supersedes Technical Service Bulletin Group 91 number 16-97 dated December 19, 2016 for reasons listed below.

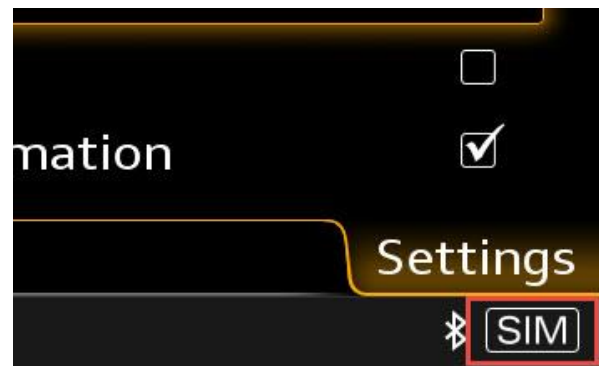
The customer complains no online services are available via the inserted SIM card. The inserted SIM card cannot be recognized by the MMI (Figure 1).

Figure 1. SIM not recognized

The internal USB port for the phone module cannot be initialized. Therefore the phone module is not recognized in the Information electronics control module 1 (J794) (address word 005F) and any SIM inserted into the MMI cannot be utilized.

If it is determined the customer's SIM card and Audi connect subscription are okay, and the SIM cannot be recognized in the customer's MMI, then the telephone module must be replaced in the MMI.

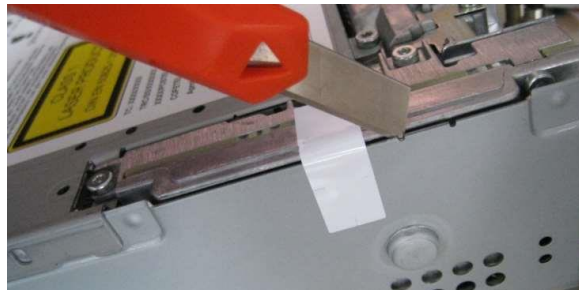
Figure 8. Warranty Seal.

8. Cut through the seal of the unit using the utility knife (Figure 8).

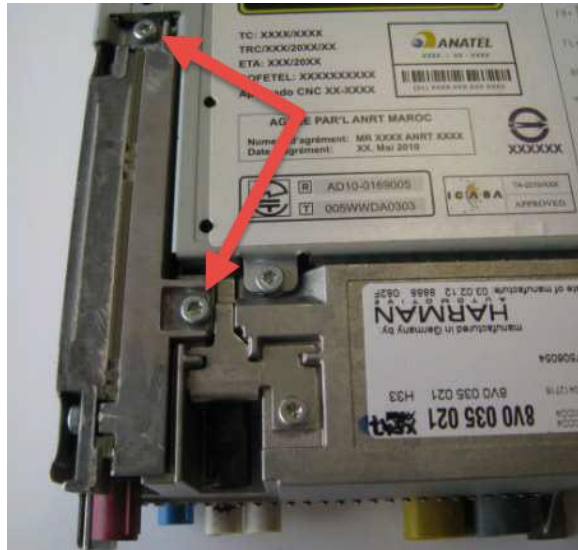
Figure 9. Telephone Module Screws.

9. Remove the two screws holding the telephone module (arrows in Figure 9).

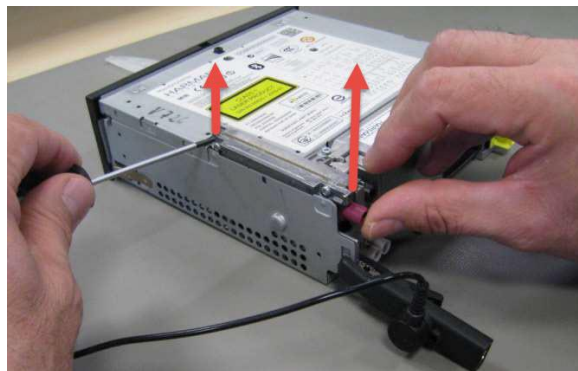
Figure 10. Lift up on both ends.

10. Lift the phone module on the inner end in direction of the arrow and at the same time on the outer end (Figure 10).

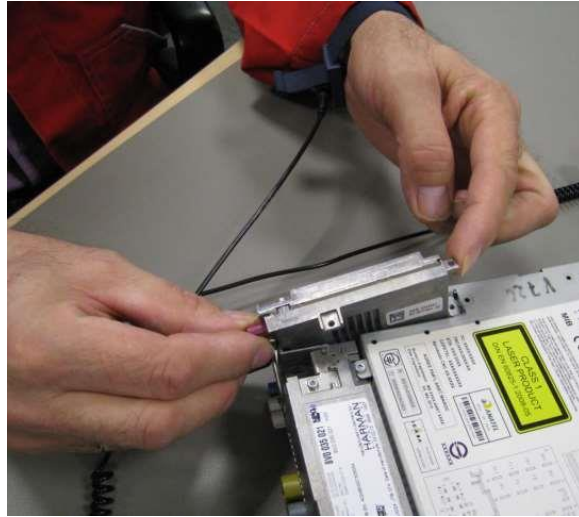
Figure 11. Remove the top out first.

11. Completely take out the phone module towards the top (Figure 11).

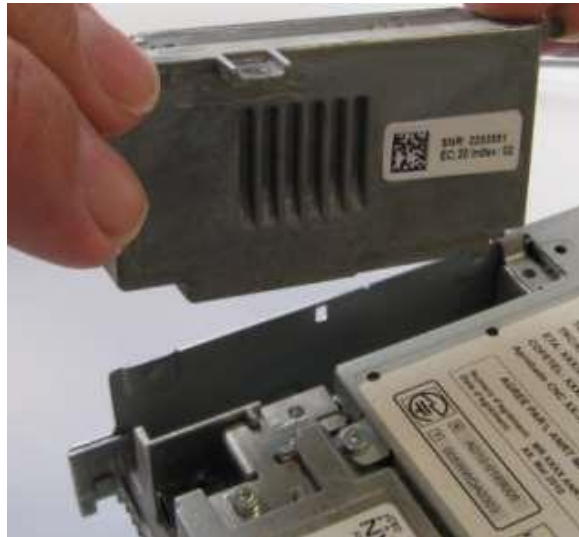
Figure 12. Insert the new telephone module.

12. Place the new phone module downwards into the channel and carefully press in the contacts (Figure 12).

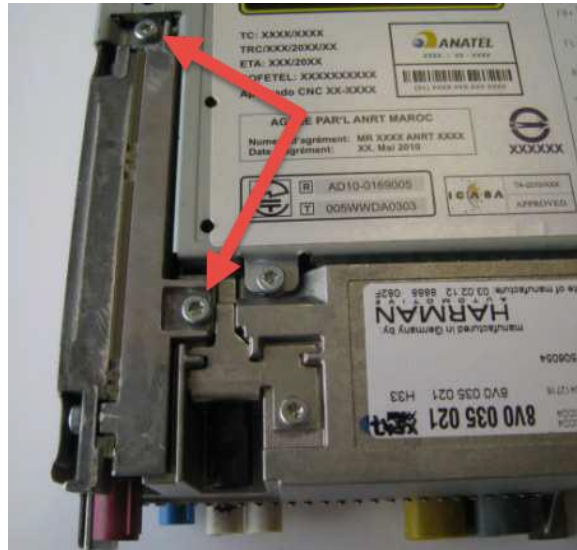
Figure 13. Do not over torque screws.

13. Slightly tighten the module with the supplied screws (arrows in Figure 13).

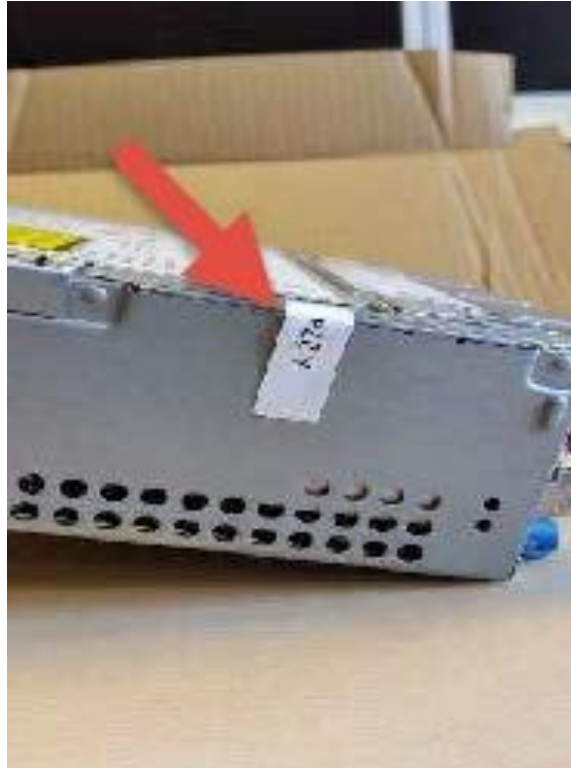
Figure 14. Apply new warranty label.

14. Stick the supplied repair sticker with the label - A 274 - on the Information electronics control module 1 (Figure 14).
