Technical Service Bulletin

91 SOS Warning Displayed On Instrument Cluster

91 17 99 2046155/2 January 4, 2017. Supersedes Technical Service Bulletin Group 91 number 16-95 dated December 12, 2016 for reasons listed below.

Model(s)	Year	VIN Range	Vehicle-Specific Equipment
A4	2016 - 2017	All	With connected gateway

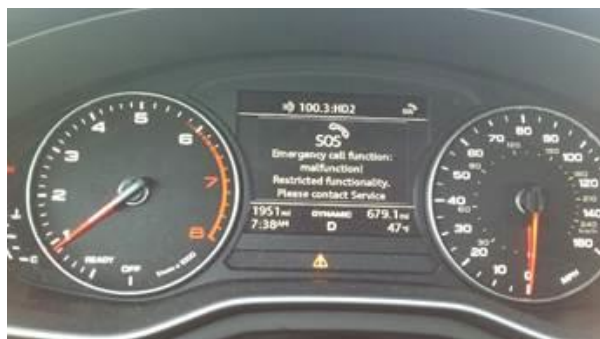
- Customer may report a SOS warning message is displayed on the instrument cluster (Figure 1)
- DTC B105313** GSM antenna Open Circuit stored in connected Gateway Module (databus onboard diagnostic interface) (address word 0019)

Figure 1. SOS warning in instrument cluster.

Poor connection in the coaxial wiring from the Gateway Module J533 to the external R263 antenna.

1. Verify the customer concern.
2. Install new antenna and bracket to correct poor connection to Gateway Module J533.
3. Gain access to the right rear body harness by removing the following. Consult repair manual for instructions:
 - Rear Shelf
 - D-Pillar Trim Panel - Right
 - C-Pillar-Trim Panel - Right
 - Side Cushion – Right
 - Rear Seat Belt Guide – Right
 - Rear Sill Panel – Right
 - Rear Bench Seat
4. Insulate the mounting points for the new antenna bracket (8W0035596):
 - Right mounting hole (Figure 2)
 - Cut three, 1 inch long strips of adhesive tape (D373125A2)
 - Forward and rear facing sides of mounting hole: place one of the 1 inch strips (Figure 2A)
 - Left and right sides of mounting hole: cut the remaining 1 inch strip in half, making two 1/2 inch strips. Place one of the 1/2 inch strips on the left side and the other on the right side of the mounting hole (Figure 1C)
