**Technical Service Webinar**  
January, 2017

# Technical Service Webinar

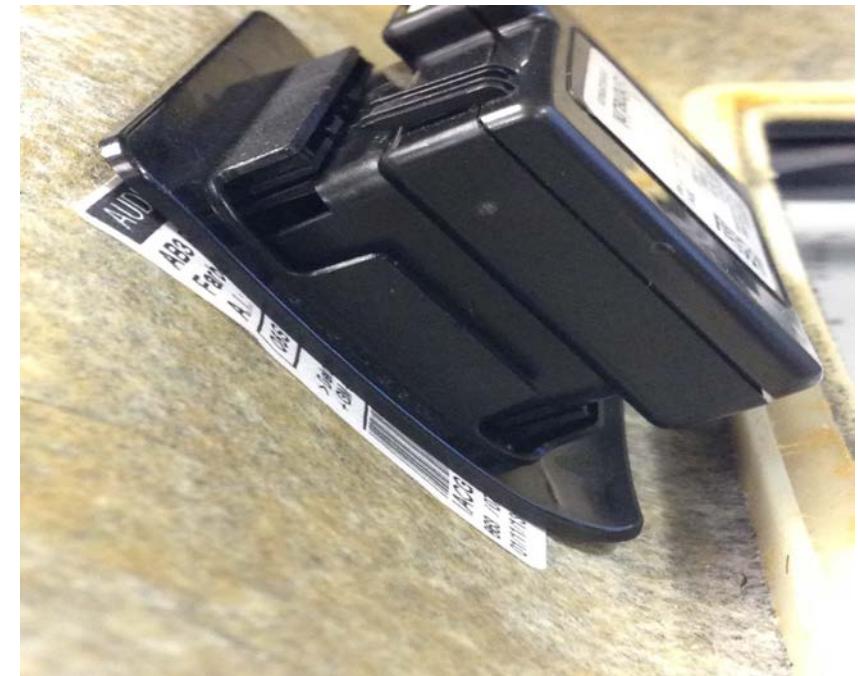
Example of HomeLink module unclipped

- Verify the module is properly clipped to the button assembly at all 4 corners.
- Verify the trim ring is properly clipped to the button assembly
- Trim ring must be installed with the raised edge pointing towards the overhead roof/lamp assembly.
- Check that the headliner is cut properly and the fitment of the buttons are correct
- Most of the time the module has simply became unclipped from the button assembly and can be re-assembled

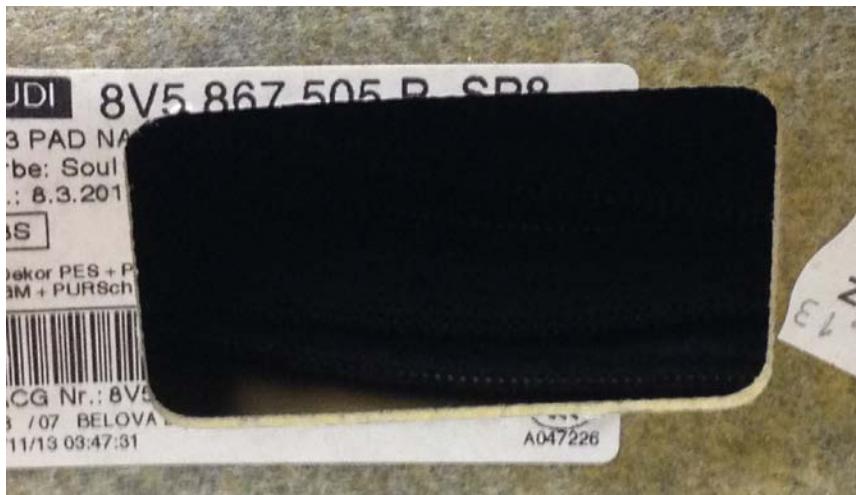
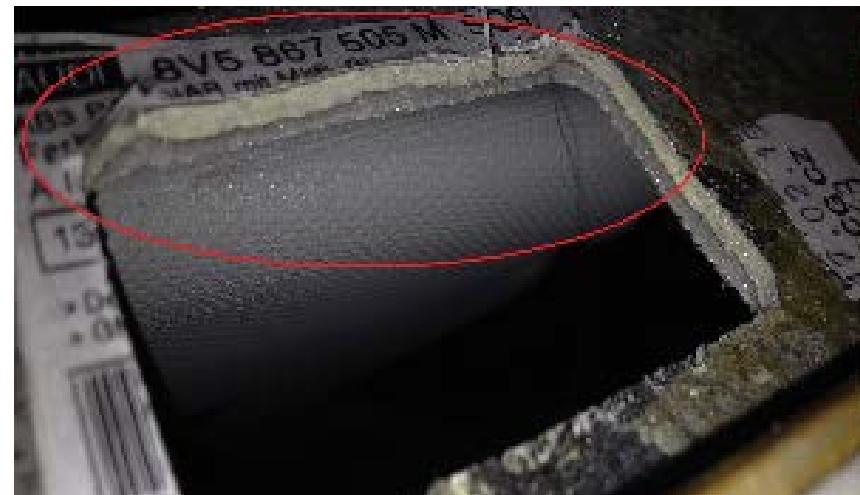
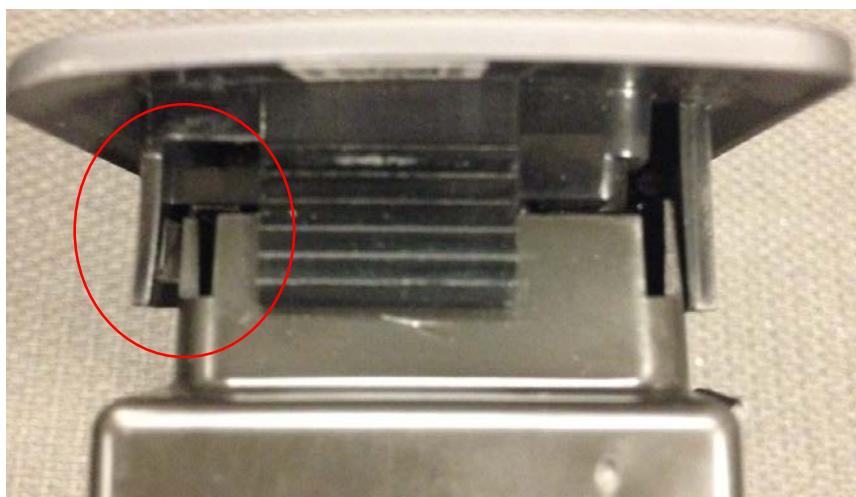
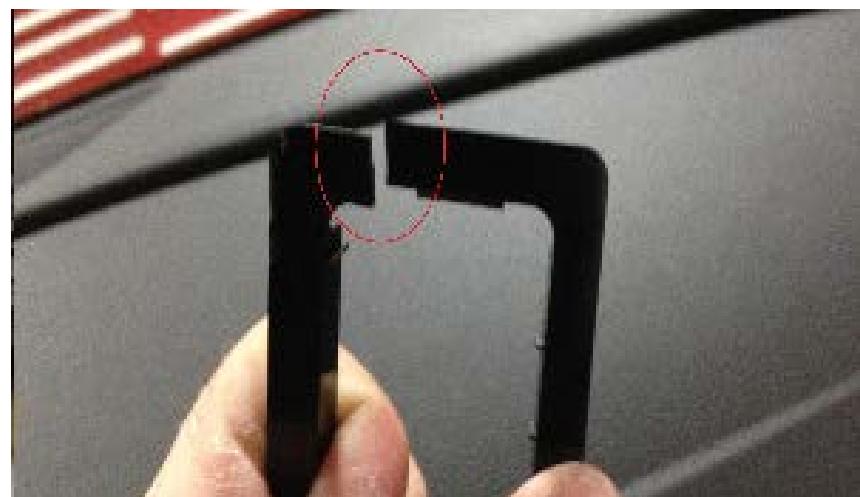
Examples of damage to the components

- Remove the HomeLink module and inspect the assembly for any signs of damage.
- If no damage is found, re-assemble all 3 components on the bench and re-check operation. If the buttons now work, re-install them into the vehicle and check the operation. **Note: No TAC case is required in this case.**
- If damage to any of the components is found OR the assembly easily dislodges again, please take the necessary photos and create a TAC case. Include the photos and part number needed for the parts release.

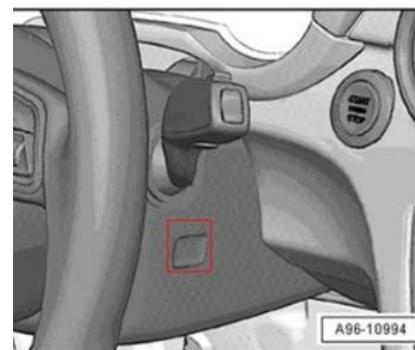
Figure 1. Emergency coil reader.

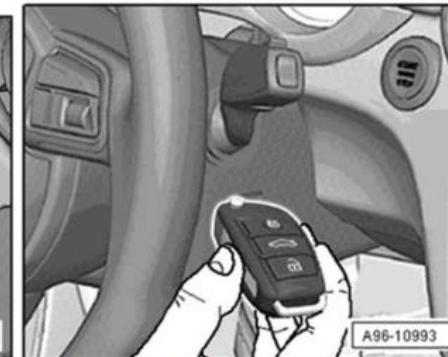
Figure 2. Hold top of key against coil.

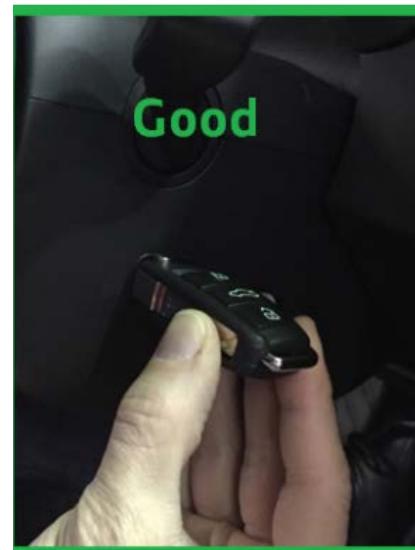
The key was not completely adapted to the immobilizer. Key position is crucial for proper key adaptation.

Figure 3. The correct way to hold the key while adapting it.

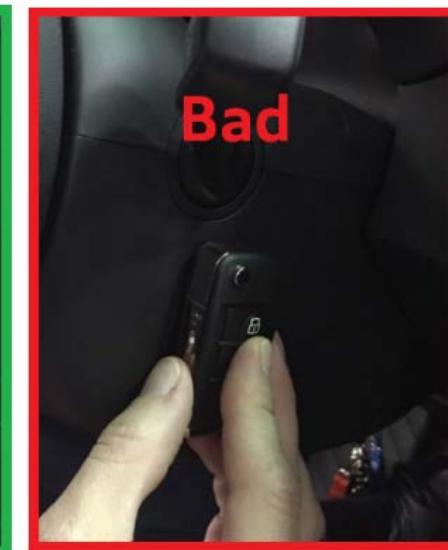
Figure 4. The incorrect way to hold the key while adapting it.

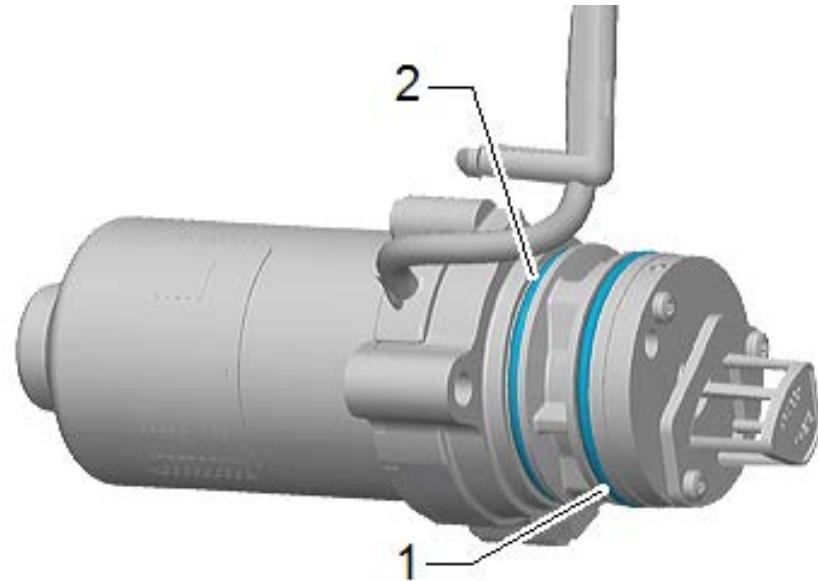
- All-wheel drive does not work.
- The EPC warning lamp is illuminated.

- DTC C111204 (All Wheel Drive clutch pump faulty) in J492
- U011400: Lost Communication With Four-Wheel Drive Clutch Control Module

**Cause:** There is an internal leak in the hydraulic pump.

- Before proceeding, confirm that the issue matches the *Condition* exactly.
- Confirm that the propeller shaft from the transmission to the differential is transmitting power to the rear differential.
- Replace the BorgWarner clutch pump according to the Elsa Repair Manual.
- Replace the high performance oil for the BorgWarner clutch according to the Elsa.
- Perform all-wheel drive basic settings after repairs have been completed.
