**RECREATIONAL VEHICLE SERVICE CAMPAIGN**

**SERVICE ADVISORY 17-294**

### Coleman 1755 Furnace Return Vent

It has been determined that on some 2017-2018 Coleman 1755 models built in plant 840, a furnace return vent was not installed. This advisory explains how to correct the problem if it exists.

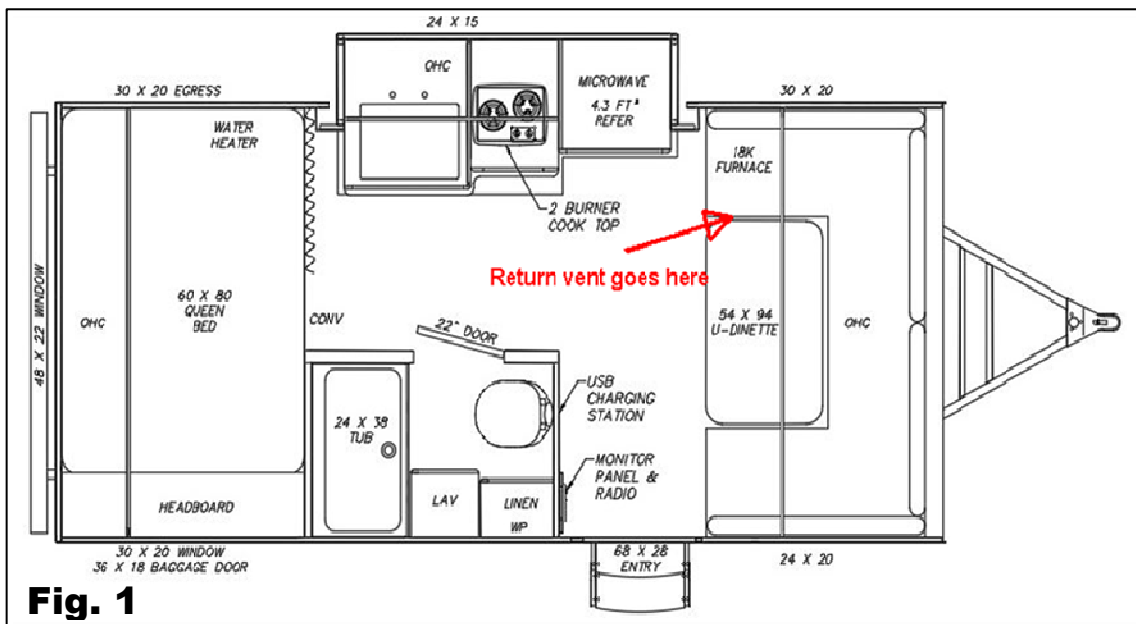
Locate the furnace under the dinette seat on the off-door-side towards the front of the unit, Figure 1.
