H045NAS1

TECHNICAL BULLETIN

Service Action: A-Pillar Water Ingress

MODEL:	MODEL YEAR:	VIN:	ASSEMBLY PLANT:
XE (X760)	2018	P24441-P25363	Castle Bromwich

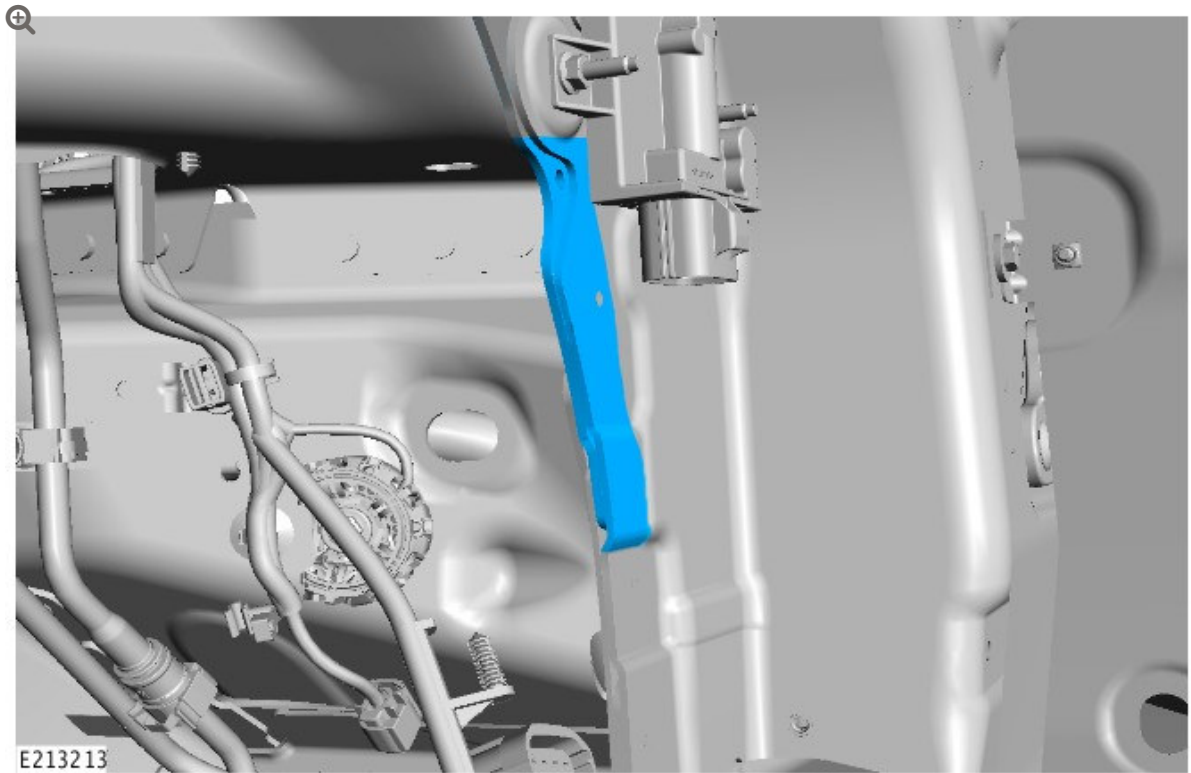
4

An issue has been identified on certain vehicles within the listed Affected Vehicle Range which may have been manufactured away from process and, in some cases, the A-Pillar sealant has not been applied correctly. This could lead to water ingress into the footwell area.

Vehicles with a Fuel Pump Driver Module (FPDM) only: do not block the hole for the FPDM wiring harness clip.

Apply sealant in the area shown (Sikaflex 221 or equivalent).
