JTB00368NAS4

**TECHNICAL BULLETIN**

501-17: Roof Opening Panel

'Creak' Noise From Panoramic Roof While Driving with Roof Opening Panel Closed

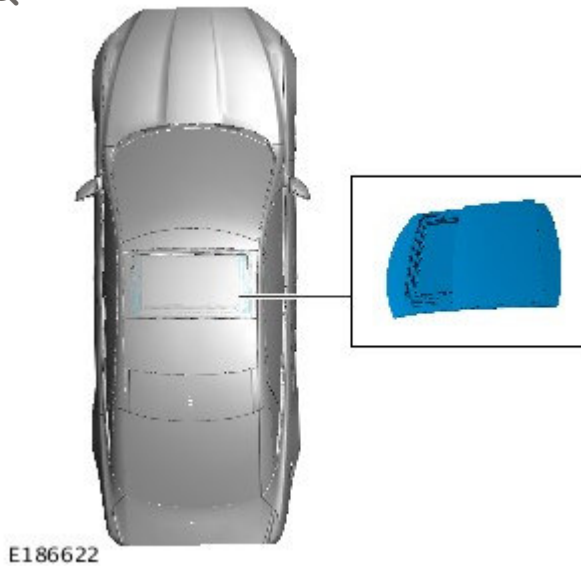
- The roof opening panel rear edge interior tooth feature coming into contact with the roof frame when closed; **and/or**
- Movement between the sliding roof panel mechanism arm and the locking arm during torsional inputs to the vehicle.

Component location.

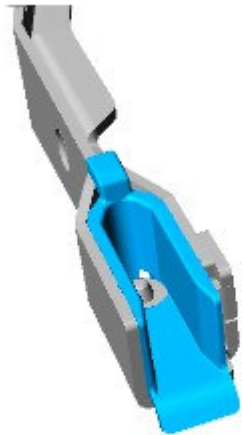
**E192104**

With the roof opening panel in the fully open position, check if the left and right rear mechanism inserts are installed.

- 1 If both left and right rear mechanism inserts are installed, no further action is required.
- 2 If one or both rear mechanism inserts is missing, go to Step 2.
