JTBO0580NAS1

TECHNICAL BULLETIN

501-25C: Body Repairs

Water Leak Into Front Footwell(s)

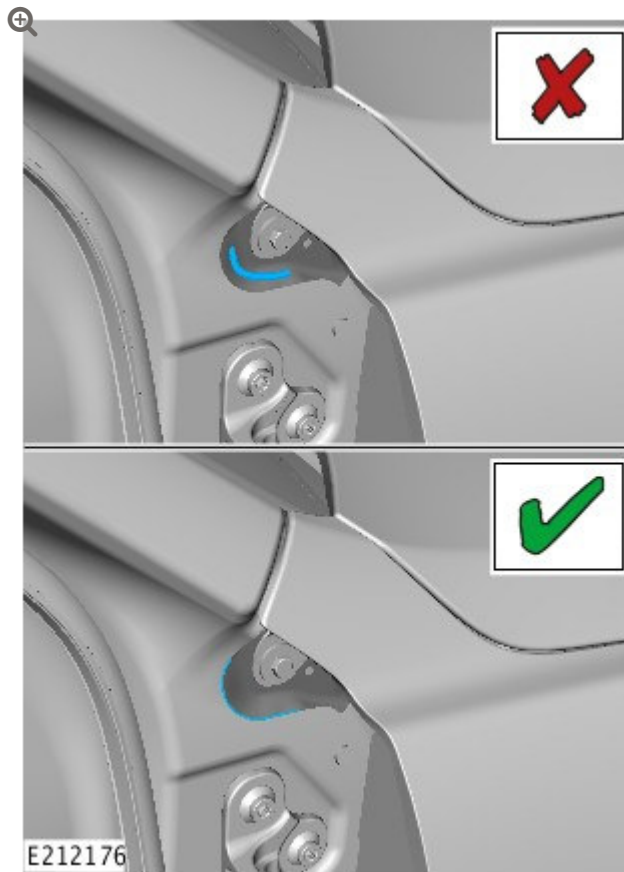
Right A-pillar area shown; left A-pillar area similar:

This may be caused by incorrect sealant application during the build process.

- ✘ - Silicone sealer not spread over the panels.
- ✔ - Silicone sealer spread onto adjacent panels.

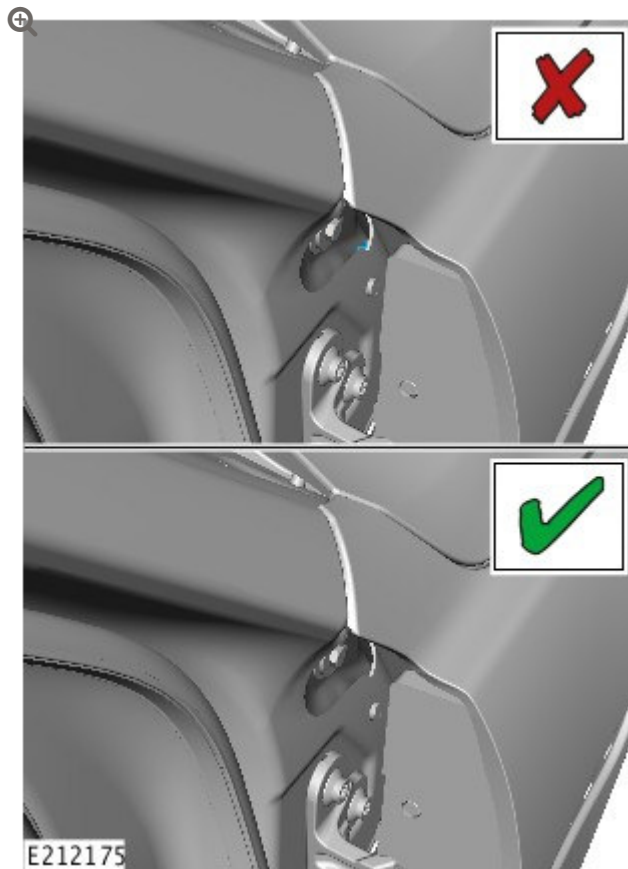
Right A-pillar area shown; left A-pillar area similar:

- ✘ - Body putty visible on the outside of the panels.
- ✔ - Body putty not visible on the outside of the panels.
