MODEL: Karma Revero**DATE:** September 2017**TITLE:** Intercooler Charge Air Pipe Inspection**First Release****PRIORITY:** On Complaint**APPLICABILITY:** MY17 and MY18 Revero**MARKET REGION:** North America**PURPOSE:** Inspect the intercooler hose clamp for proper alignment

TB-17-12-19

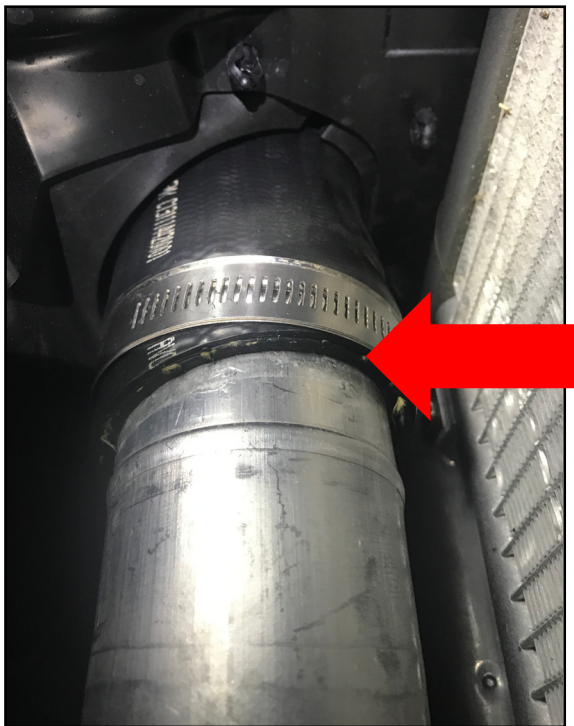
fig.1a

A visual inspection may show a misaligned clamp and hose immediately, this will require action (fig.1a and 1b).

NOTE: This is from the underside of the vehicle. The other clamps are accessible from the top

The complaint will vary in presentation through diagnostic trouble codes related to air/fuel ratio imbalance or underboost condition. Inspect the hose clamps for the intake system and ensure they are lined up correctly and all hoses are located properly. Loosening of the clamp to adjust the hose may be required. Reinstall to the specified torque value (8.5 +/- 0.5Nm).
