Michael A. Berardi
 Director
 Service Engineering Operations
 Ford Customer Service Division

September 21, 2017

SUBJECT: **NEW VEHICLE DEMONSTRATION / DELIVERY HOLD – Customer Satisfaction Program 17B25 – *Supplement #1***
 Certain 2013-2017 Model Year Police Interceptor Utility Vehicles
 Exhaust Odor and Carbon Monoxide Complaints

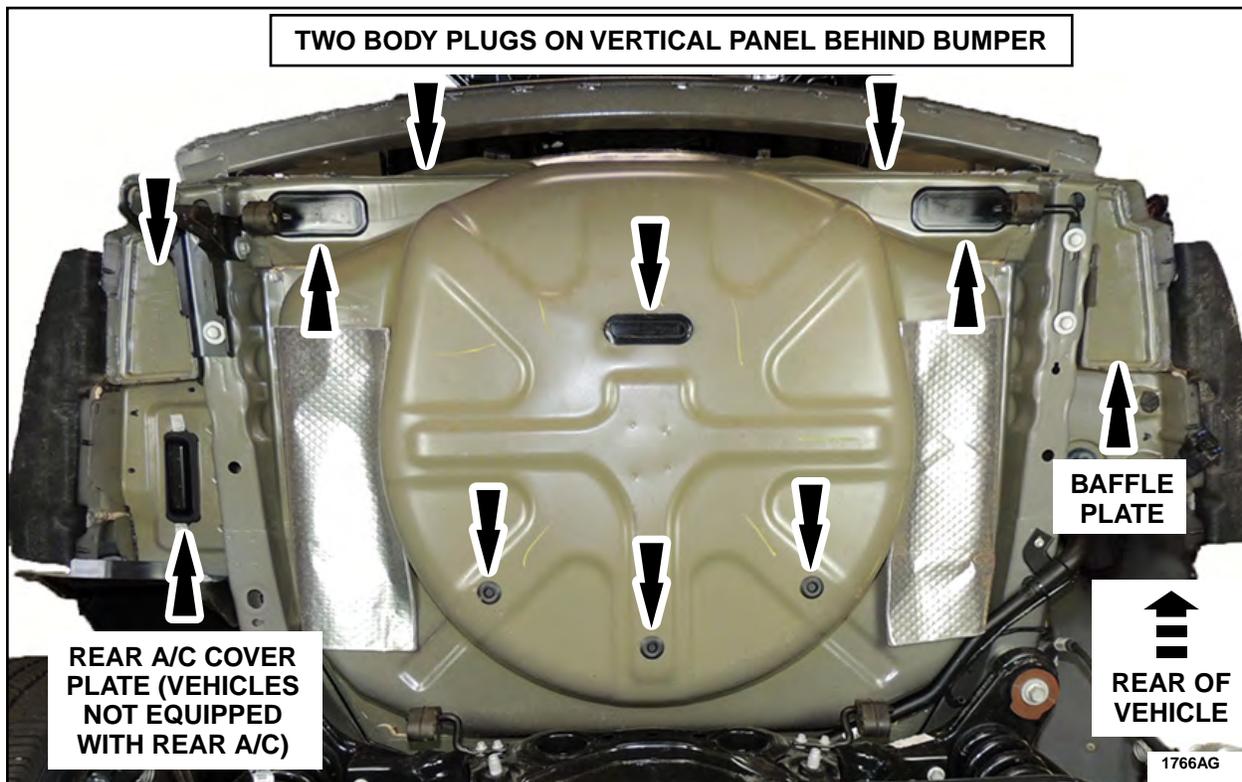
FIGURE 1

1. With the vehicle in NEUTRAL, position it on a hoist. Please follow the Workshop Manual (WSM) procedures in Section 100-02.
2. Inspect the rear underbody for damaged or missing body plugs, punctured/damaged floor pan sheet metal and baffle plates, damaged wiring harness grommets, aftermarket fasteners, and pass throughs (holes) created for aftermarket wiring/equipment. See Figures 1, 2a and 2b.
 - Seal all aftermarket wiring and equipment pass throughs using Motorcraft® TA-2 seam sealer or equivalent, and Foil-Backed Mastic Patch as needed.

NOTE: Do not use silicones, RTVs or caulks during this repair.

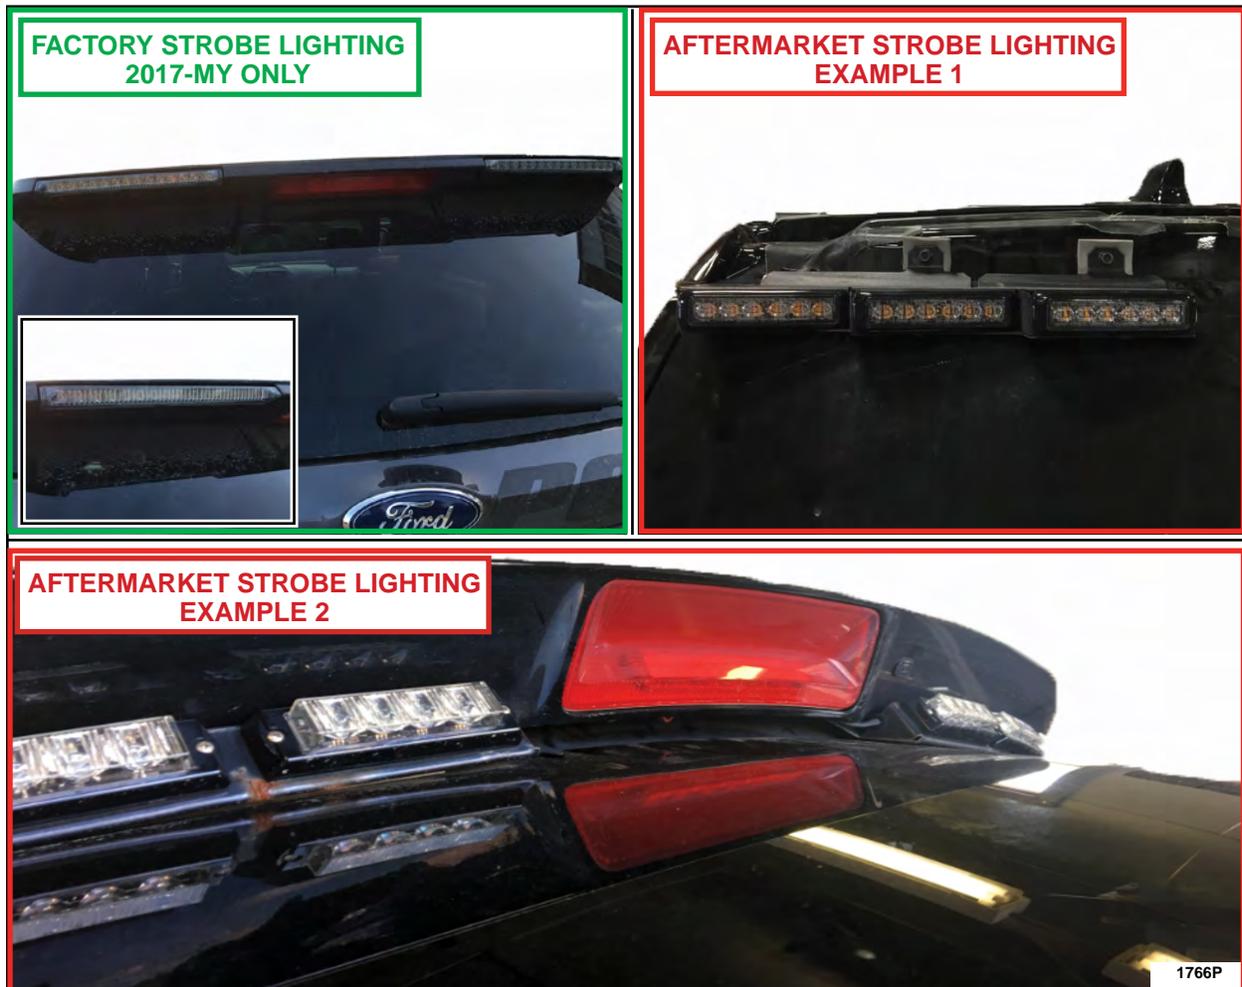
FIGURE 9

NOTE: Aftermarket lighting and/or equipment mounted to the liftgate spoiler can compromise vehicle sealing and create a leak path for exhaust to enter the vehicle. Ford recommends removal of any aftermarket lighting and/or equipment mounted to the spoiler to prevent a potential path for exhaust to enter the vehicle. Any removed equipment must be returned to the customer.

- a. Is there aftermarket lighting or other equipment mounted to the spoiler? See Figure 9.
- b. Has the spoiler or vehicle been painted?
NOTE: All Police Interceptor Utility Spoilers are painted black from the factory.
- c. Is the spoiler damaged or have any holes drilled through it?
- d. Is any aftermarket wiring routed to the spoiler?

Yes – Proceed to the Liftgate Spoiler Sealing Procedure.

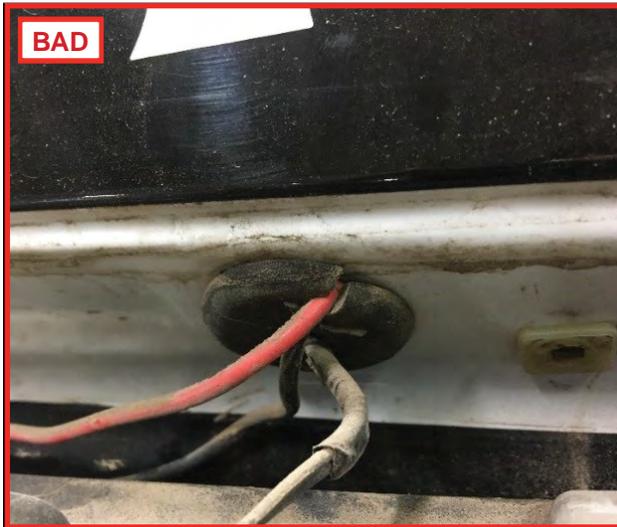
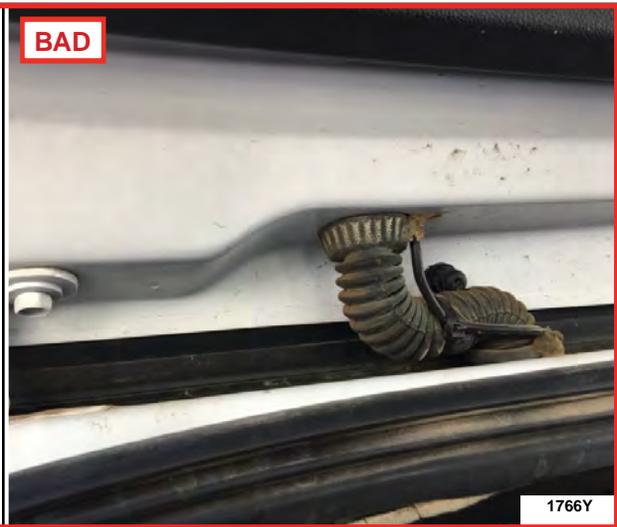
FIGURE 11a

2. Inspect for any aftermarket wiring pass throughs/holes that could affect the sealing ability of the spoiler. See Figures 11a and 11b.

3. Seal any leak paths created by the aftermarket wiring pass throughs/holes in the spoiler area with Motorcraft® TA-2 seam sealer or equivalent.
