Rattling noises in area of 2-stage turbocharger, OM651

Topic number	LI09.40-P-064267
Version	5
Design group	09.40 Turbocharger
Date	05-10-2017
Validity	Engine OM651 in model 166, 172, 205, 222, 253 Engine OM651 in model 204, 207, 212, 218 (with code B03)
Reason for change	Remedy adjusted; no replacement of plastic valve instead of creating a TIPS case
Reason for block

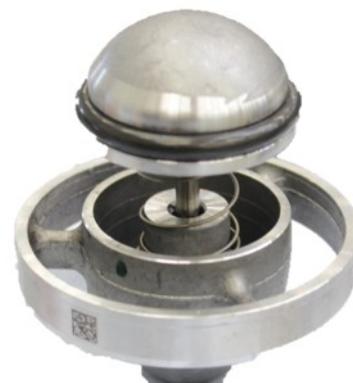
Pic 1.jpg:

1. Belt tensioner.
2. Vibrations of the aluminum bypass valve inside the air duct housing.

Attachments	
File	Description
Pic 1.jpg	Aluminum valve
Pic 2.jpg	Plastic valve

- If a silver-colored aluminum valve (Pic 1) is installed, replace the air duct housing.
- If a black plastic valve (Pic 2) is installed, the air duct housing must NOT be replaced.

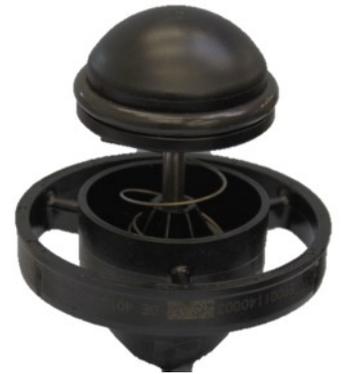
Pic 2.jpg:

Note: The part number of the air duct housing was not changed when converting from the aluminum to the plastic valve.
