## COMAND: Message "Metadata Loss" or navigation menu constantly displays "Activating"

| Topic number | LI82.85-P-066038 |
| Design group | 82.85 Navigation and Communication system (CNS, ICS, COMAND, FleetBoard) |
| Validity | Model 216, 221 as of model year 2010 (code 800/801/802/803) with COMAND APS (except code 529)<br>Affected VIN ranges: as of 216.#####A023933, as of 221.#####A286400 |

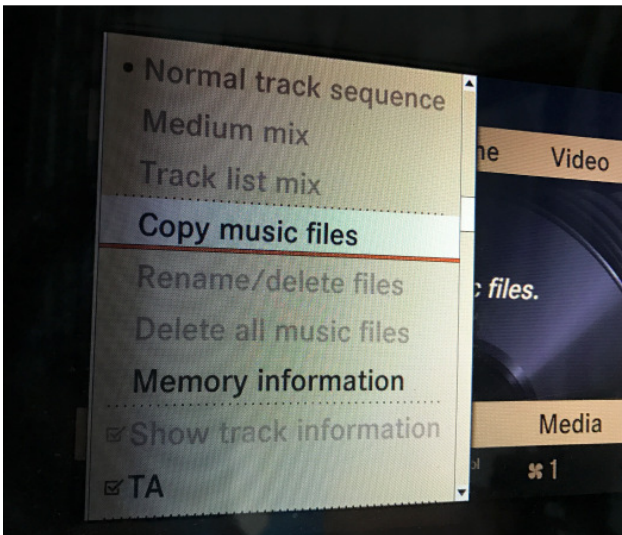
no bug

1. One time message "loss of all meta data"
2. possible to select „Copy music files“ or „Memory information“ in music register
3. Try to copy mp3 files to music register
4. When all possible and message "meta data loss" only appears after first start up you can ignore message
5. Navigation map data available
6. No need to replace the head unit

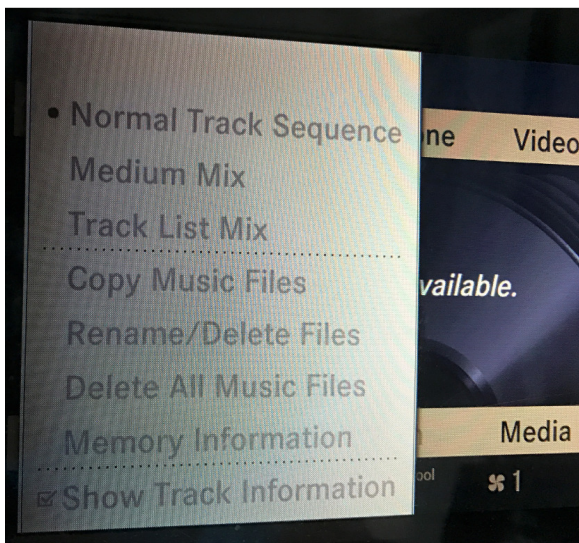
## Meta data loss issue

1. Not able to select any content of the music register
2. Wait a few minutes, check power supply
3. Reset the head unit back to factory settings
4. Navigation map data still remains in "activating please wait"
5. Message "loss of all meta data" pop up after start up

If the problem is still present, the HDD of the COMAND unit (A40/3) must be replaced in accordance with the WIS document.
