## Front turn signal inoperative

| Topic number | LI82.10-P-066270 |
| Validity | Model 463 up to VIN end number X226541 |

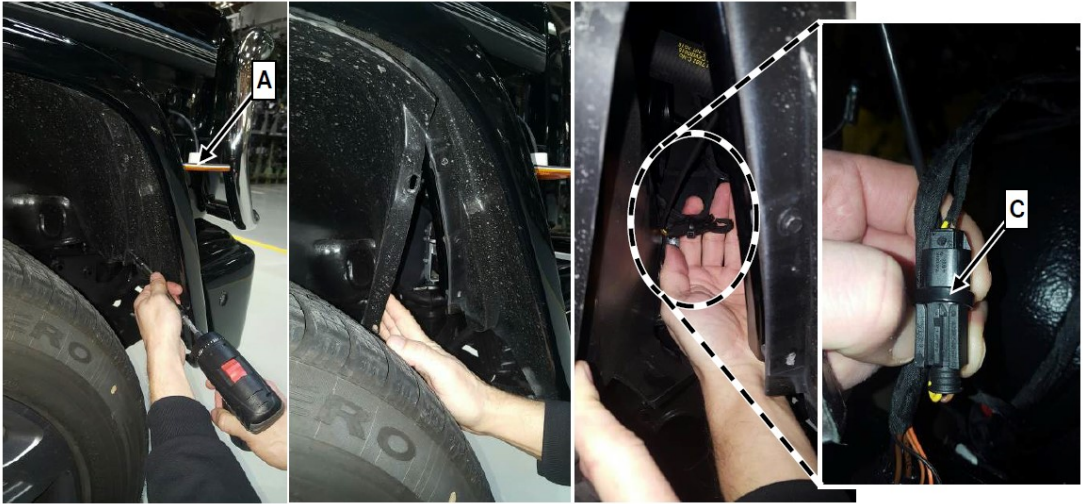
Picture 1.jpg:

| Attachments | |
|---|---|
| Picture 1.jpg | Front side marker lights |

1. Disconnect ground line of battery.
2. Convert to LED side marker lamps at right and left front (A, Picture 1).
  - 2.1 To do so, partially release the front wheel arch liner and replace the electrical connector (C, Picture 1) on the vehicle wiring harness including the connector pins. Pay attention to wire colors and connector assignments!
3. Convert to LED side marker lamps at right and left rear (B, Picture 2).
  - 3.1 To do so, replace the electrical connector (C, Picture 2) on the vehicle wiring harness including connector pins (C, Picture 2). Pay attention to wire colors and pin assignments!
4. Replace front SAM control unit (AR54.21-P-1254GW).

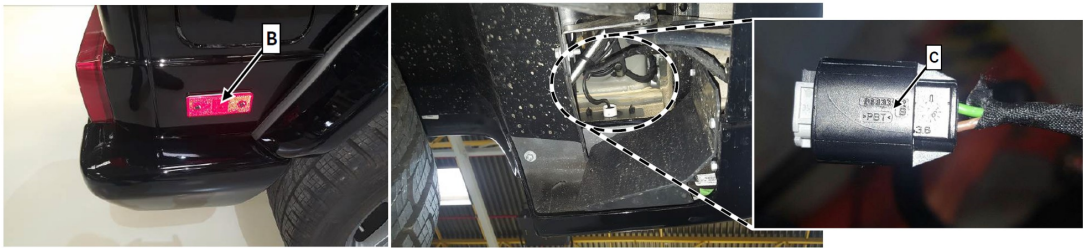
Picture 2.jpg:

| Attachments | |
|---|---|
| Picture 2.jpg | Rear side marker lights |
