## Creaking noises from backrest structure A/C205

| Topic number | LI91.10-P-066297 |
| Design group | 91.10 Front seats |
| Validity | BR 205 A/C |

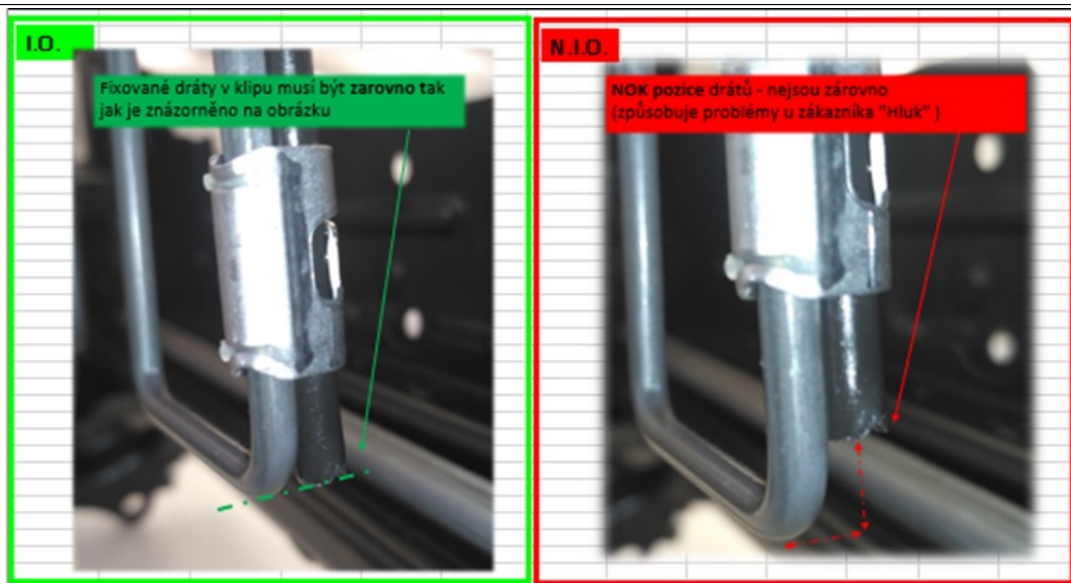
Pic1.jpg:

| Attachments | |
|---|---|
| Pic1.jpg | Complaint: Z-misalignment |

Z-misalignment of longitudinal wire in spring mat (Pic.1). This may lead to creaking noises because the spring mat is no longer under tension.

- 1) Cut three strips (12 mm X 30 mm) of felt A 000 983 71 10
- 2) Fold the strips in half with your fingers and place on the wire (Pic.2)
- 3) Wrap the felt completely around the wire (Pic.3)

Important: To ensure that the strap is not trapped, the seam of the felt strip must be on the outer bending radius of the wire.

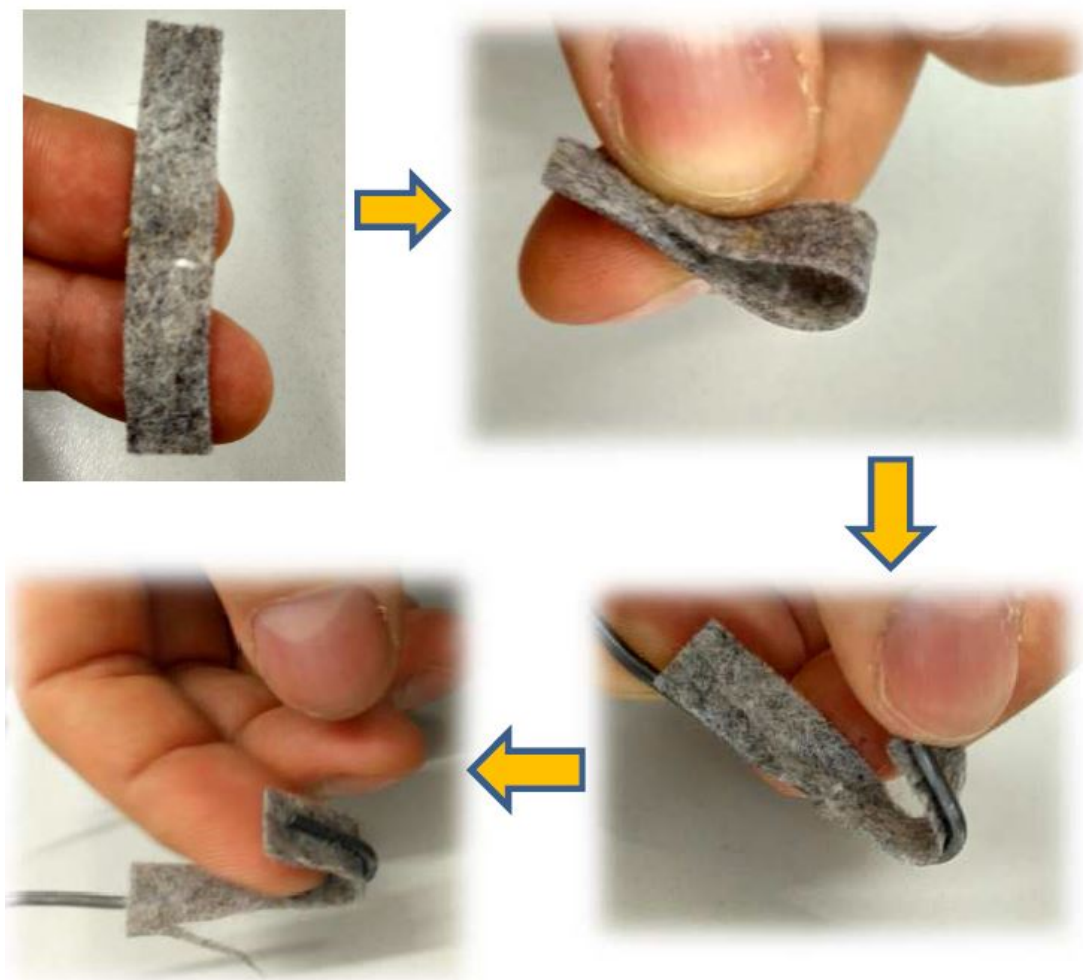
Pic2.JPG:

| Attachments | |
|---|---|
| Pic2.JPG | Wrapping the wire with felt |

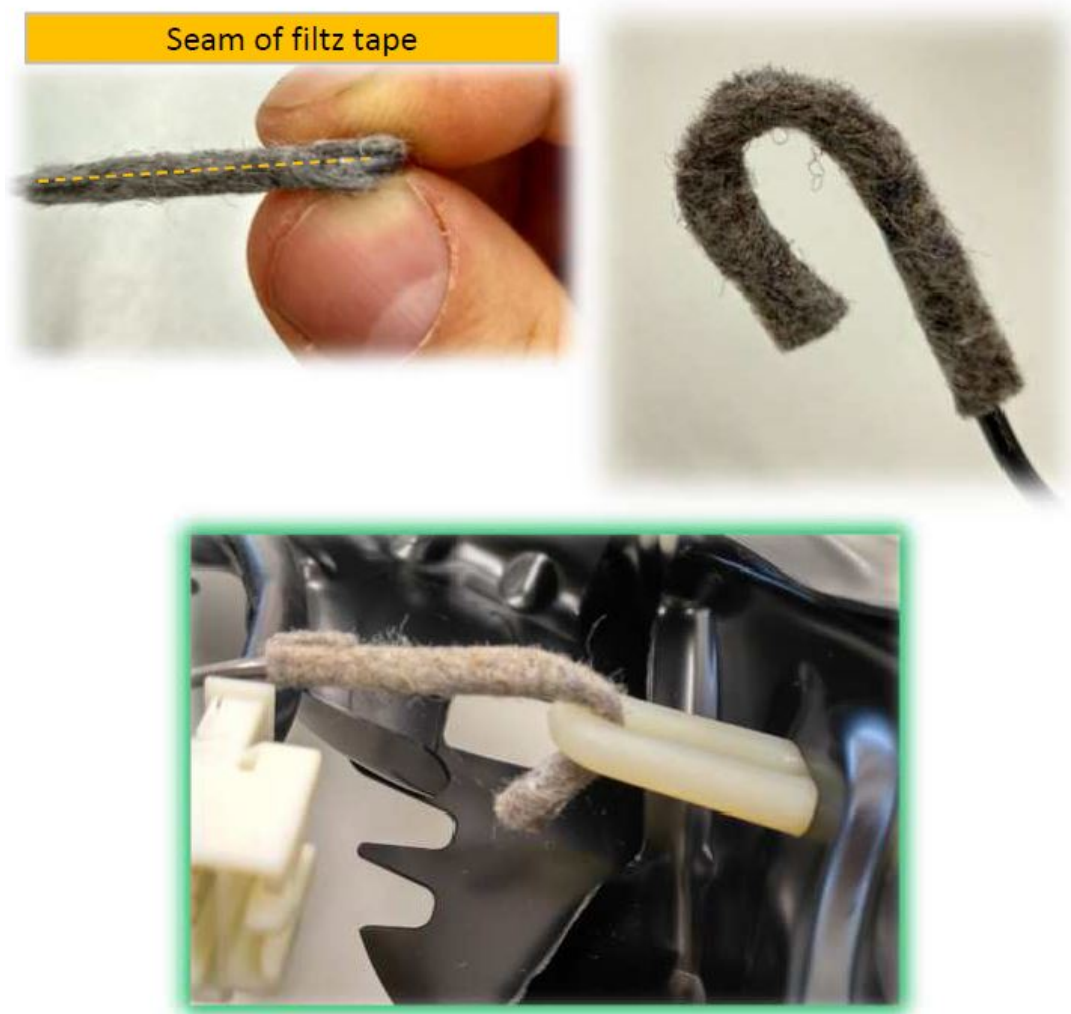
Pic3.JPG:

| Attachments | |
|---|---|
| Pic3.JPG | Wrapped wire |
