## Technical Information Bulletin

### E184

PACCAR MX-13 EPA2013 MY2016 Incorrect Allison Flywheel

6/6/2017

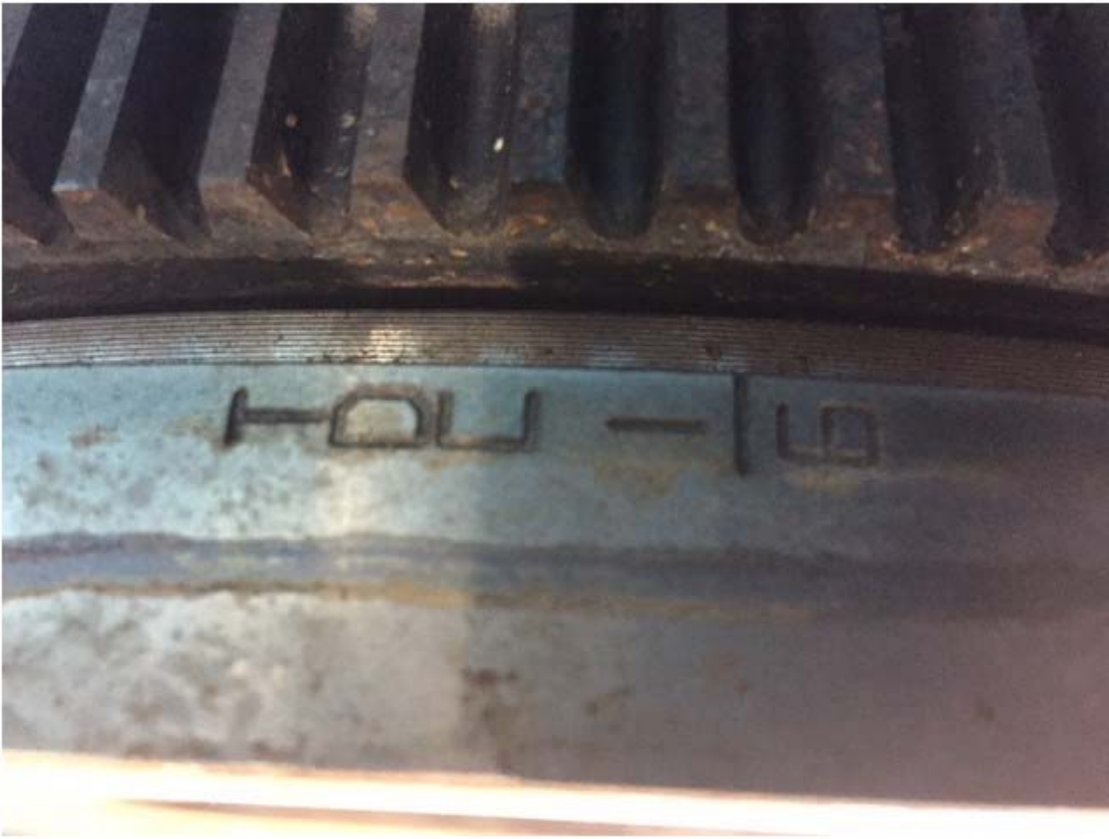
1. Remove the Access Plate.
2. Turn the engine over until the TDC mark is visible through the access port.
  - If the 1 and 6 are next to the TDC mark, the flywheel is correct. No further action is needed.

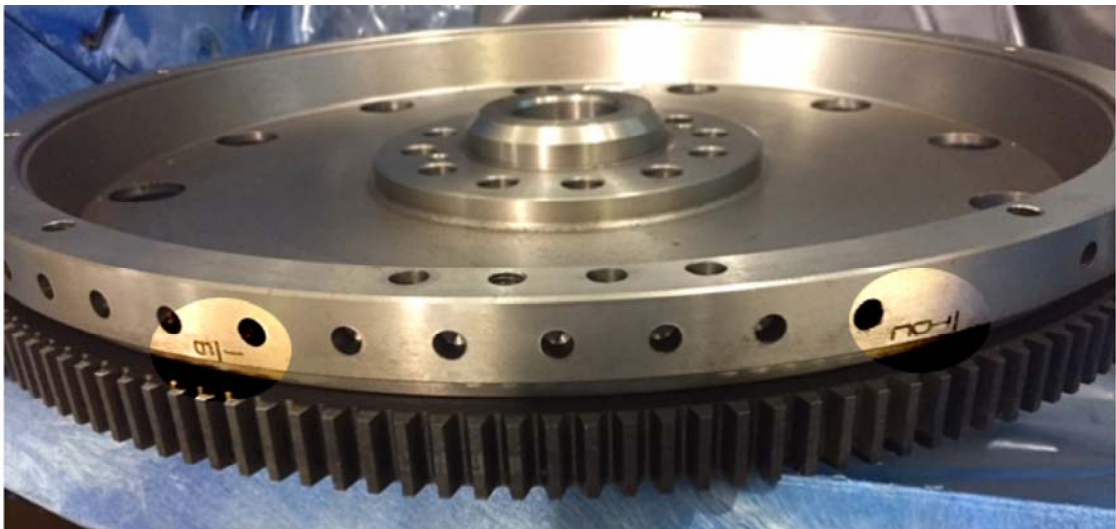
- If the 1 and 6 are separated from the TDC mark, the flywheel is incorrect. Order a new flywheel as referenced in the parts section.
  - Replace the flywheel using appropriate service documentation. Transfer the Flexible plate (1778068) and bolts to the new flywheel.

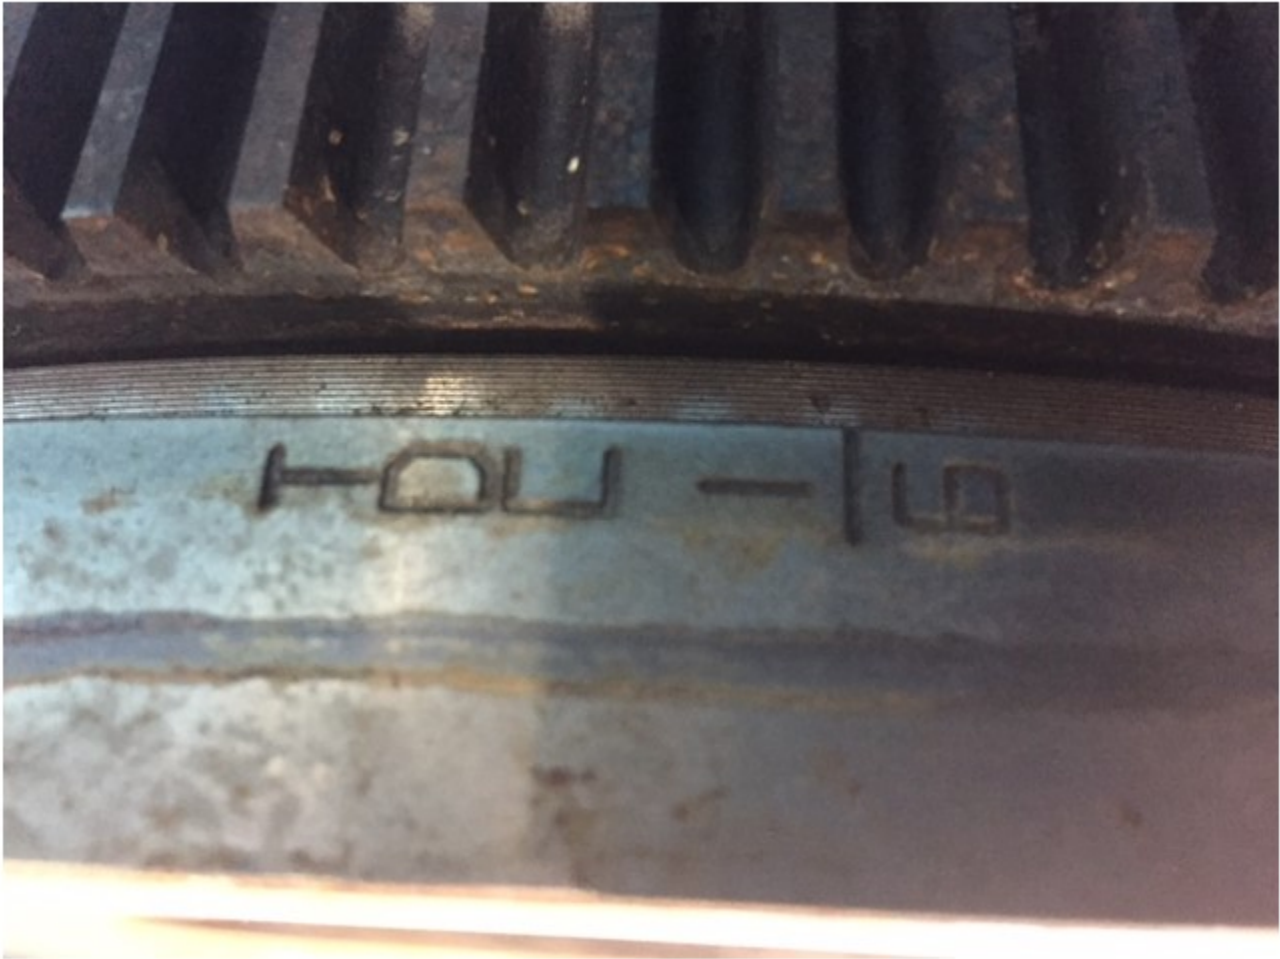
- If the 1 and 6 are next to the TDC mark, the flywheel is correct. No further action is needed.

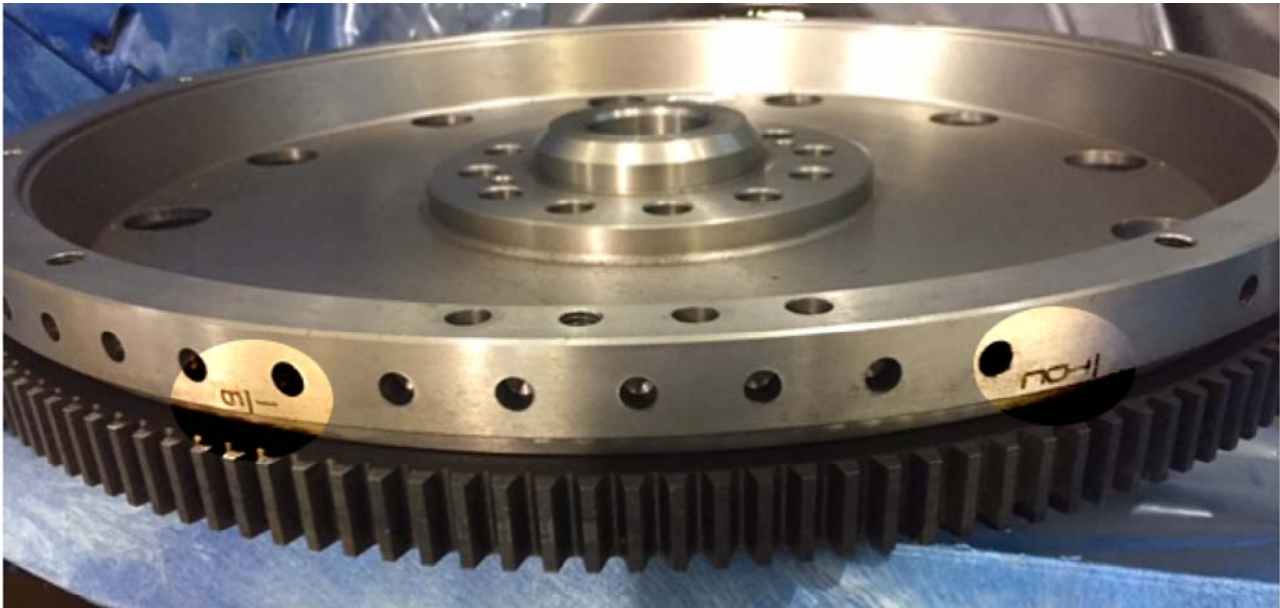
- If the 1 and 6 are separated from the TDC mark, the flywheel is incorrect. Order a new flywheel as referenced in the parts section.
- Replace the flywheel using appropriate service documentation. Transfer the Flexible plate (1778068) and bolts to the new flywheel.
