## Repair Notice

**916-2**

The Peterbilt SmartAir System may shut down without warning.

6/30/2017

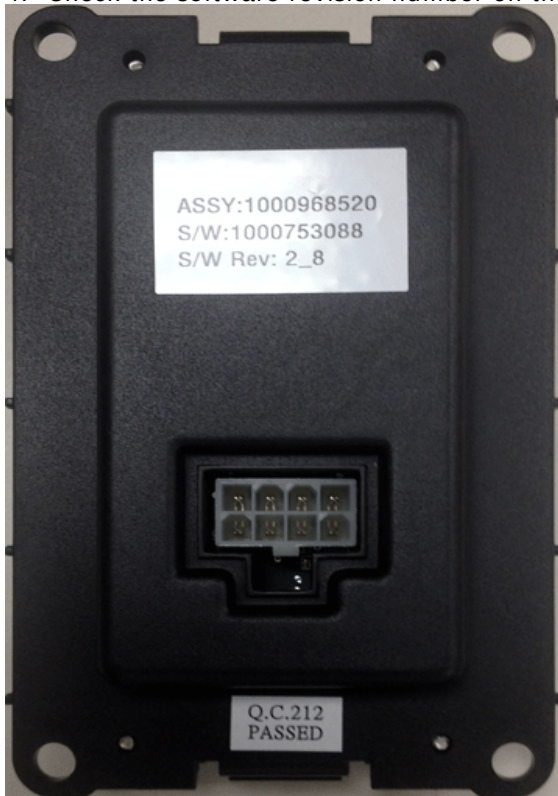
4. Check the software revision number on the back of the control panel:

5. If the revision number is 2.9 or higher, reinstall the control unit.

- If the software revision number is 2.8, replace the control unit with a control unit loaded with software revision 2.9 or higher.
