# Technical Bulletin

**87 17 04** April 18, 2017 **2040184** Supersedes Technical Bulletin V871703 dated March 9, 2017 to add additional fault P0CEB00: Coolant pump for low temperature circuit.

**Climatronic with Heat Pump - Sporadically Too Low Heating or Cooling Performance**

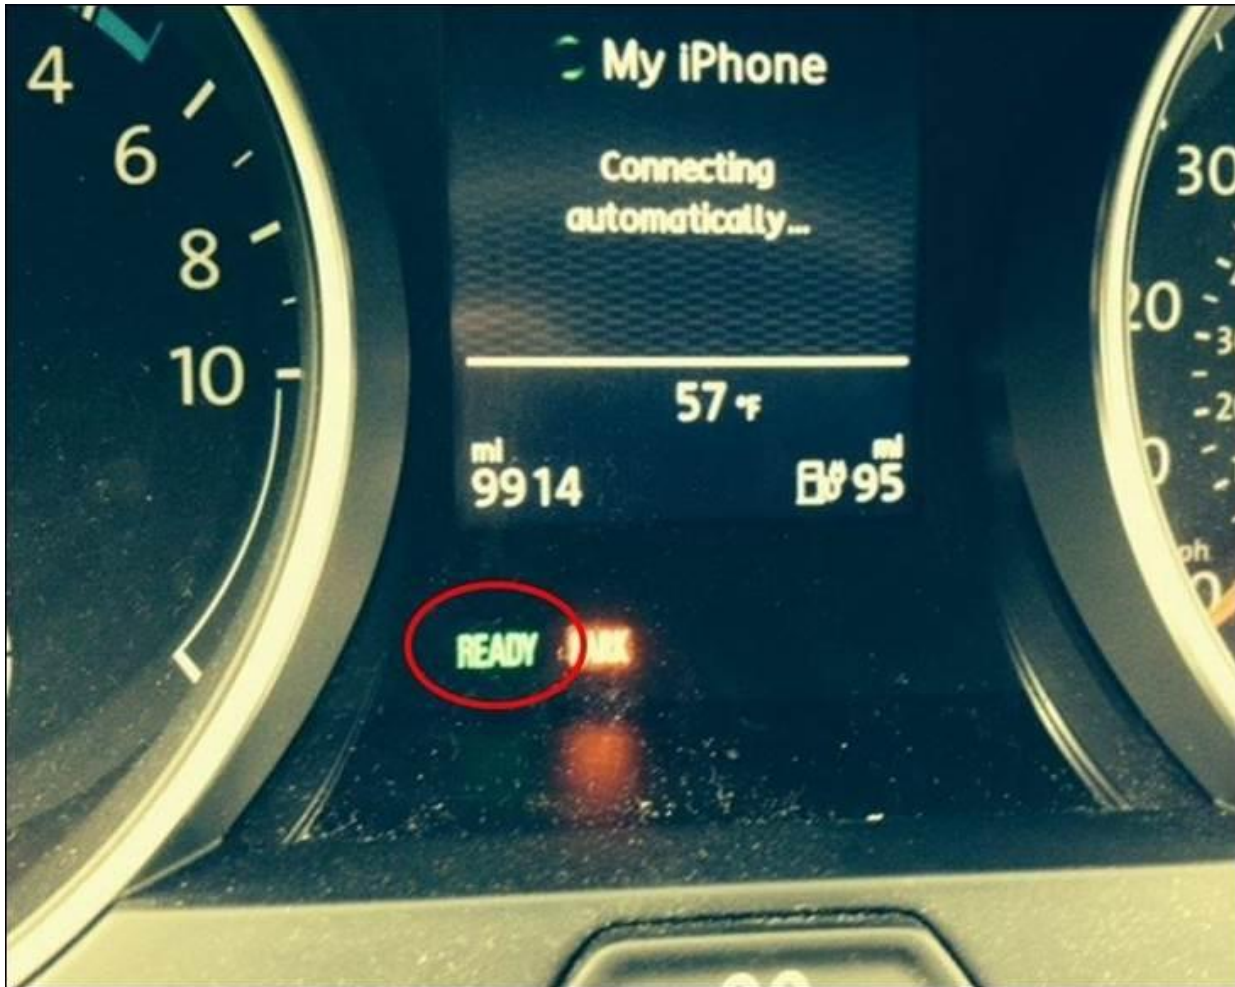
Figure 1

After the software update is complete, an initial run of the compressor must be carried out according to the Guided Functions. The start switch must be ON, brake pedal depressed and electric motor indicator in the instrument panel in READY status (Figure 1). The initial run of the compressor will not complete without READY status illuminated.
