Technical Service Bulletin

Mazda North American Operations
Irvine, CA 92618-2922

Subject: 01-005/17 OIL SEEPAGE AT ENGINE FRONT COVER	Bulletin No.: 01-005/17
	Last Issued: 06/02/2017

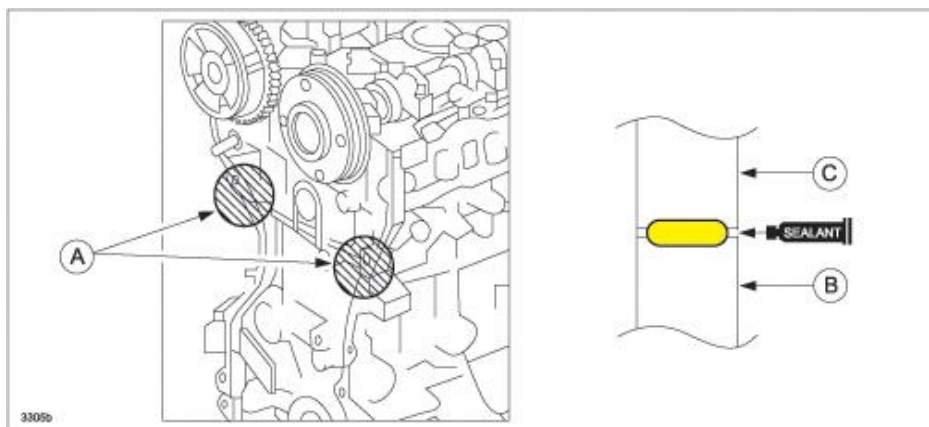
This may be caused by oil escaping from a fine clearance created at the sealant applied to joint (A) between the cylinder block (B) and head (C) when the engine was pressurized during leak testing on the engine assembly line.
