# Technical Service Bulletin

01-007/17 - LACK OF POWER / INTAKE AIR LEAK NOISE FROM ENGINE COMPARTMENT

**Bulletin No.:** 01-007/17

2016-2017 CX-9 vehicles with VINs lower than JM3TC\*\*\*\*\*134298 (produced before Dec. 23, 2016)

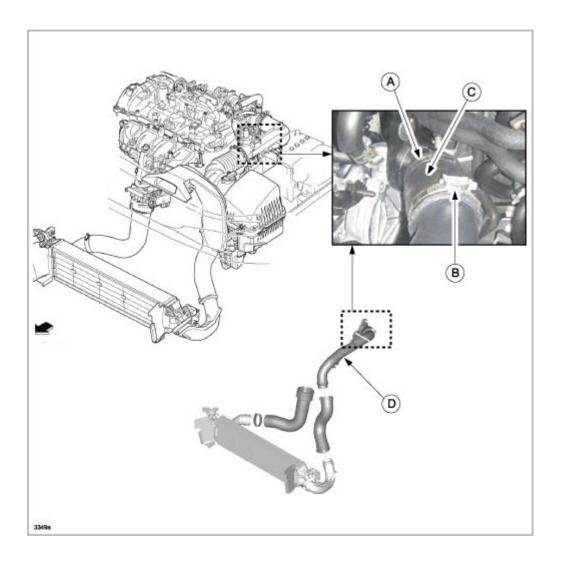
Some vehicles may exhibit a lack of engine power / intake air leak noise from the engine compartment. Hose clamps A and/or B for the air hose (C) for the turbocharger air outlet pipe (D) may be loose due to insufficient tightening.

The tightening torque of the hose clamps has been increased to eliminate this concern.
