# Technical Service Bulletin

05-002/17 HARD SHIFTING/SHIFT LEVER VIBRATION

Bulletin No.: 05-002/15

Last Issued: 06/12/2017

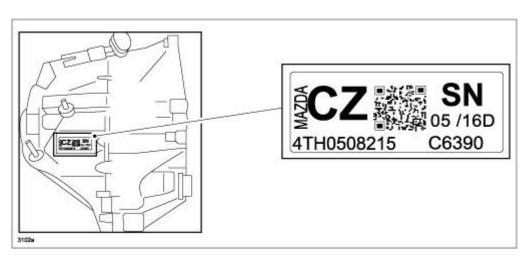
**NOTE:** The modification(s) applied to the transmission can also be found from the transmission number. The transmission number is printed on the label attached on the top side of the transaxle case. Refer to the below table for the beginning transmission numbers of each modification.

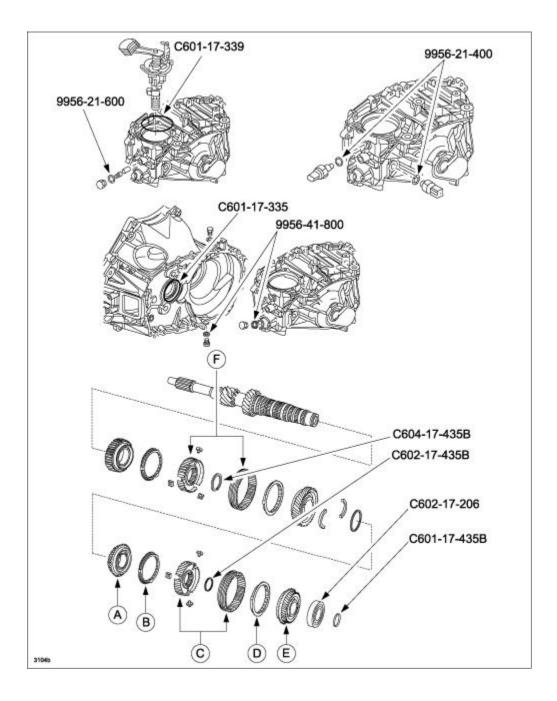
Location of Transmission Related Parts

A: 3rd Gear

B: 3rd Synchronizer Ring

C: 3/4 Clutch Hub Assembly

D: 4th Synchronizer Ring

E: 4th Gear

F: 5/6 Clutch Hub Assembly
