Subject: 04-003/17 SQUEAKING/GRINDING NOISE FROM REAR BRAKE	Bulletin No.: 04-003/17
	Last Issued: 06/14/2017

2014-2016 Mazda3 (Japan built) vehicles with VINs lower than JM1*****355941 (produced before June 24, 2016)

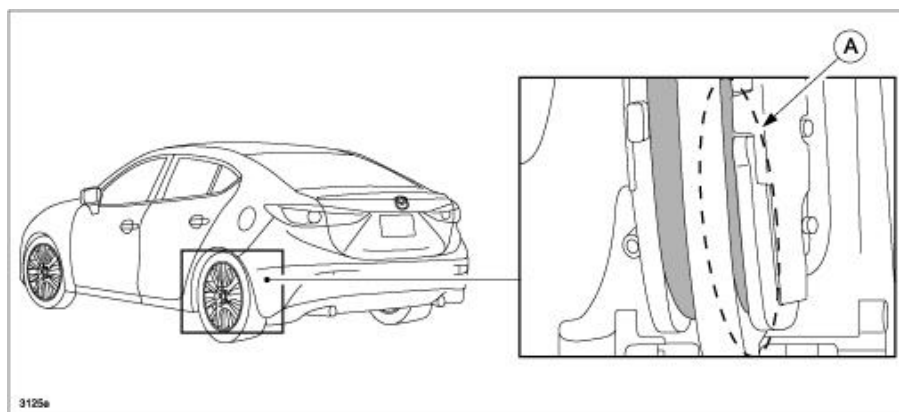
Some vehicles may experience a squeaking/grinding noise from the rear brake even after the brake pedal is released. Upon inspection, the caliper mounting support is corroded and one of the disc pad is abnormally worn out (A). This is caused by vehicle usage in an area using road salt. The surface of the mounting support may swell from corrosion causing premature disc pad wear and brake noise.

To correct the problem, an improved caliper mounting support has been newly established as a service part. The anti-corrosion surface treatment has been changed from Zn to Zn-Ni plating.

1. Verify that the caliper mounting support(s) is corroded and the disc pad(s) is abnormally worn out.
2. Replace the caliper mounting supports (both sides) with the modified service parts sets and attachments with new parts according to the instructions on MS3 online or the Workshop Manual (section 04-11 REAR BRAKE (DISC) REMOVAL/INSTALLATION).
