Subject: 09-023/17 - FRONT BUMPER COVER POPS OUT OF POSITION	Bulletin No.: 09-023/17
	Last Issued: 06/16/2017

2016-2017 CX-9

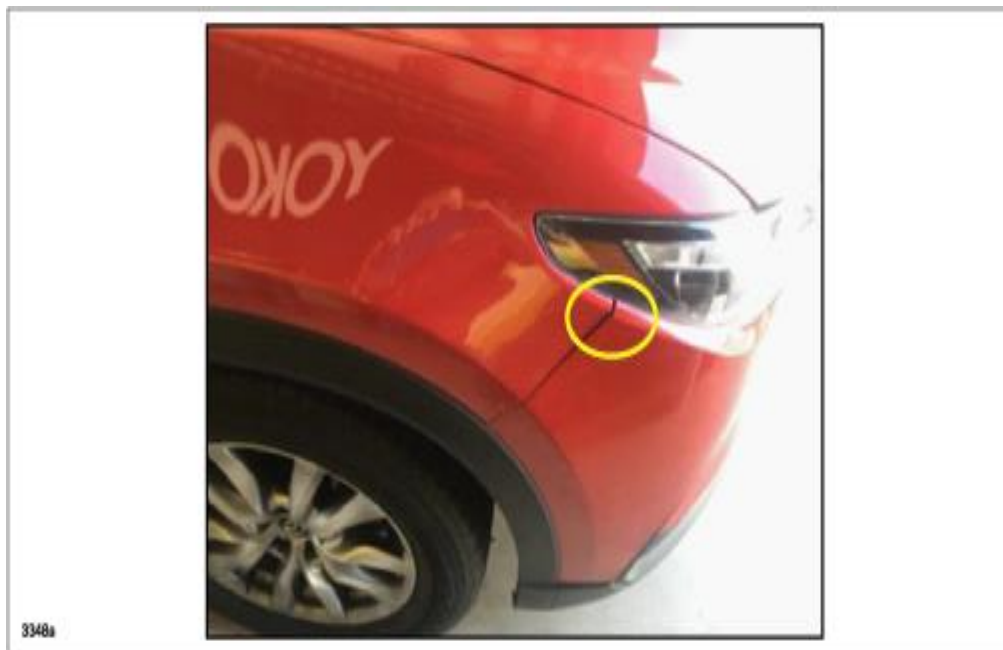
On some vehicles, the front bumper cover may pop out causing a poor appearance complaint. This may be caused by an insufficient amount of holding force of the bumper slider.

Customers having this concern should have their vehicle repaired using the following repair procedure.

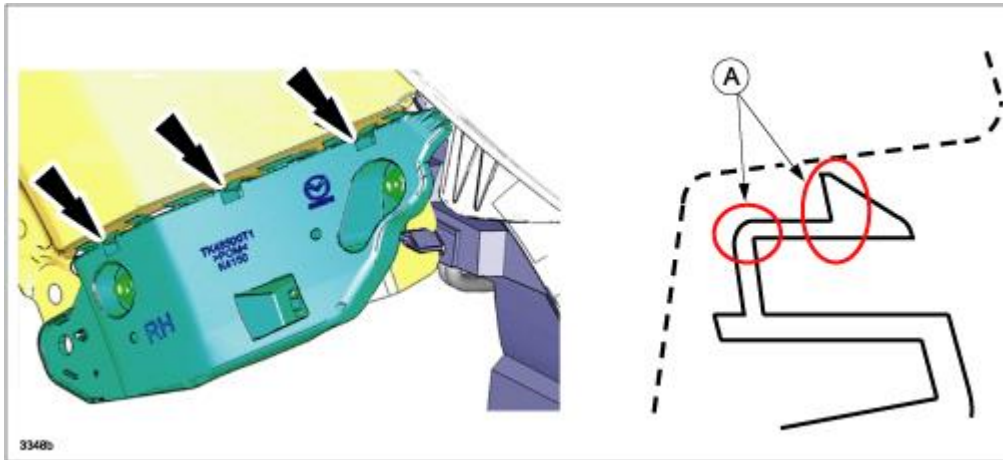
1. Verify the customer concern.
2. Remove the front bumper cover according to the instructions of MGSS online (FRONT BUMPER REMOVAL).
3. Check if the bumper slider hooks (A) are damaged and/or whitened.

- If no damage/whitening is found, proceed to next step.

- If damage/whitening is found, replace the bumper slider with a new one according to the instructions of MGSS online (FRONT BUMPER SLIDER REMOVAL/INSTALLATION).
