<b>Subject:</b> <b>09-025/17 - LEAVING HOME LIGHT FUNCTION DOES NOT WORK</b>	<b>Bulletin No.:</b> 09-025/17
	<b>Last Issued:</b> 06/16/2017

2017 Mazda6 vehicles equipped with speedometer without multi information display (MID) and with VINs lower than JM1 GL \*\*\*\*\* 128622 (produced before January 10, 2017)

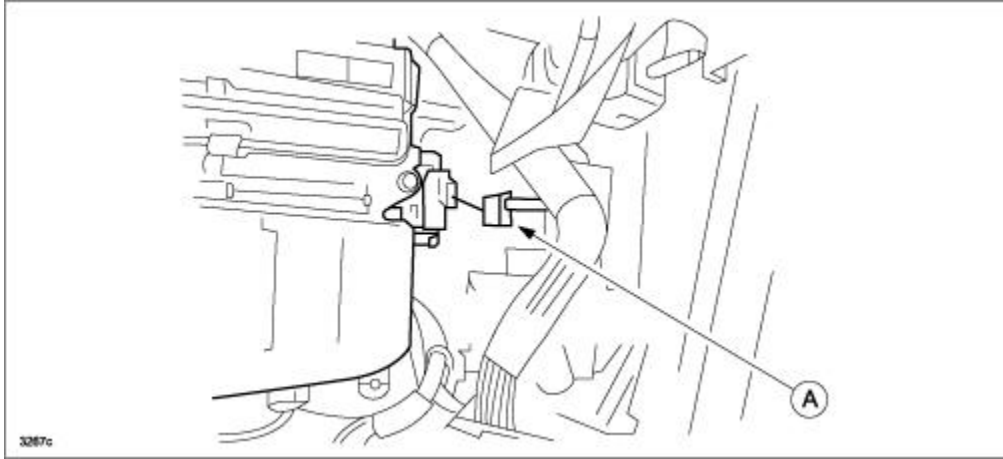
This step is to avoid the disengagement of the air intake links at the blower unit which results in no switching between REC/FRESH modes.

a. 2017 Mazda6 with VINs lower than JM1 GL \*\*\*\*\* 103945 (produced before July 18, 2016) only. Before starting the reprogramming, disconnect the air intake actuator connector (A) at the blower unit behind the glove compartment.

If the link is disengaged, refer to TSB 07-007/16.
