**09-026/17 - THIRD-ROW SEAT HEADREST DOES NOT LOCK IN UPRIGHT POSITION**

**Bulletin No.:** 09-026/17

**Last Issued:** 06/20/2017

2016-2017 CX-9 vehicles with VINs lower than JM3TC\*\*\*\*\*100980 (produced before April 1, 2017)

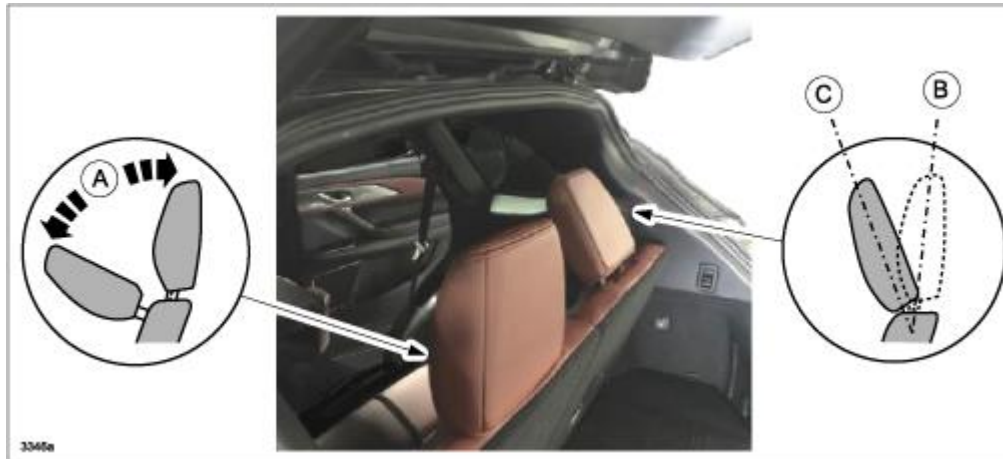
Some customers may complain that the third-row seat headrest(s) are loose (A) and do not lock in the upright position (B) or the headrest are locked in the forward-bent position (C).

Although this concern is caused by improper operation, the strength of the headrest lock mechanism has been increased to address the customer satisfaction issue. The related parts have also been modified. Customers having this concern should be instructed that they can prevent this issue from occurring by not applying excessive force to the headrests.

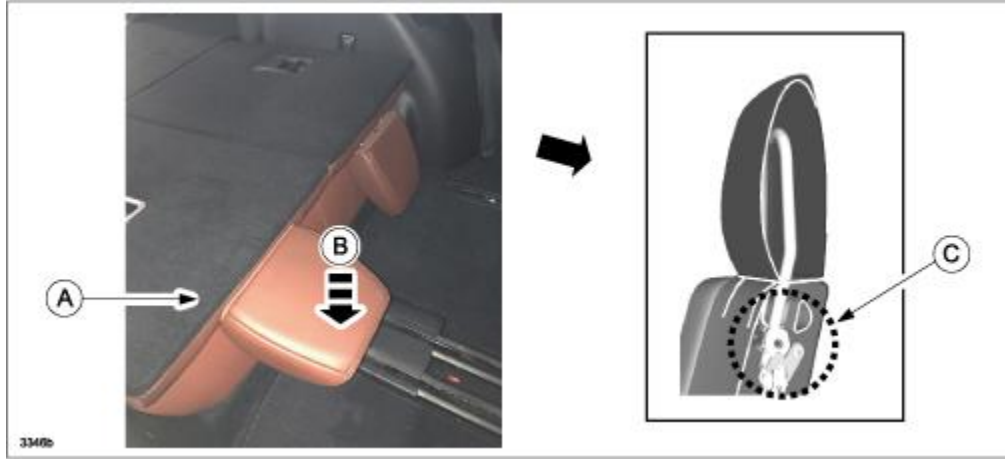
**EXAMPLE:**

These concerns are caused by improper operation while the seatback is folded down (A) and an excessive force is applied to the headrest (B) while it's in the upright locked position. When excessive force is improperly applied, this causes damage to the headrest lock mechanism (C).

Correct head restraint fold down position.	Wrong head restraint fold down position.	Damage may occur if excessive force is applied to the back of the head restraint when in the wrong position.
