<b>Subject:</b> <b>09-025/17 - LEAVING HOME LIGHT FUNCTION DOES NOT WORK</b>	<b>Bulletin No.:</b> 09-025/17
	<b>Last Issued:</b> 06/23/2017

2017 Mazda6 vehicles equipped with speedometer without multi information display (MID) and with VINs lower than JM1 GL \*\*\*\*\* 128622 (produced before January 10, 2017)

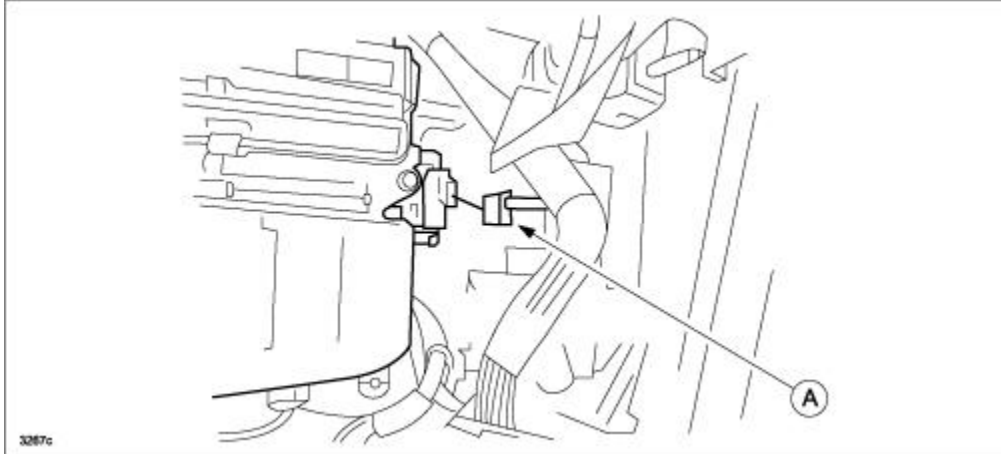
This step is to avoid the disengagement of the air intake links at the blower unit which results in no switching between REC/FRESH modes.

a. Before starting the reprogramming, disconnect the air intake actuator connector (A) at the blower unit behind the glove compartment.

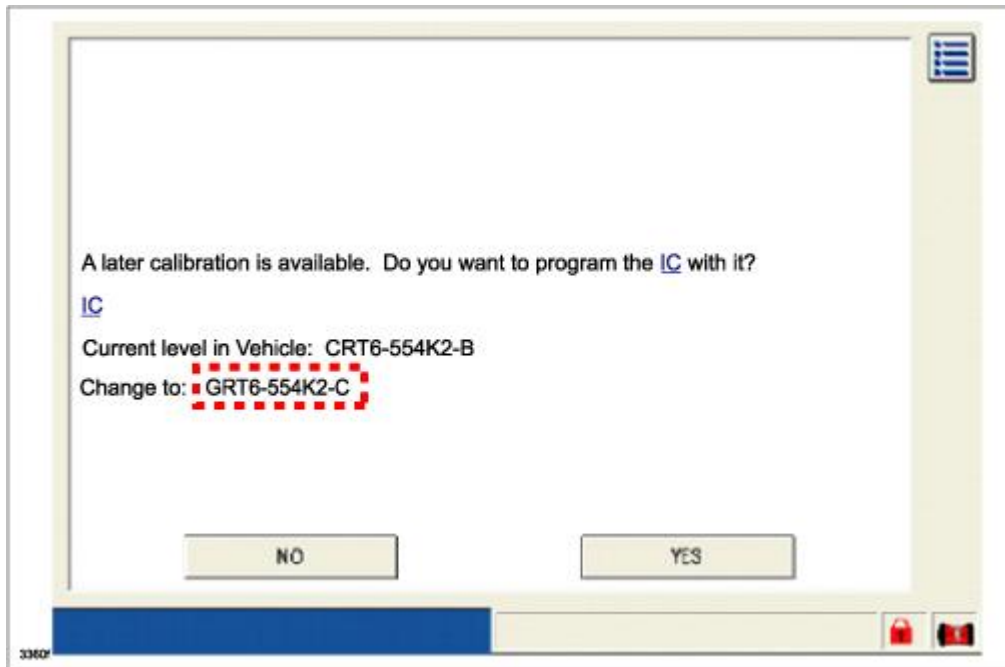
If the message “No later calibration is available on the system for this IC” is displayed, the IC is already at the latest calibration. “Current level in Vehicle” will show the new file name. This service bulletin does not apply.

c. The following screen will be displayed:  
Click “YES” and follow the M-MDS instructions to reprogram the IC.
