Subject: 09-027/17 - DRIVER SEAT LUMBAR SUPPORT ADJUSTMENT DOES NOT OPERATE	Bulletin No.: 09-027/17
	Last Issued: 06/23/2017

2014-2015 Mazda6 vehicles with VINs lower than JM1 GJ ***** 400000 (produced before November 28, 2014)

2013-2015 CX-5 vehicles with VINs lower than JM3 KE ***** 600000 (produced before November 24, 2014)

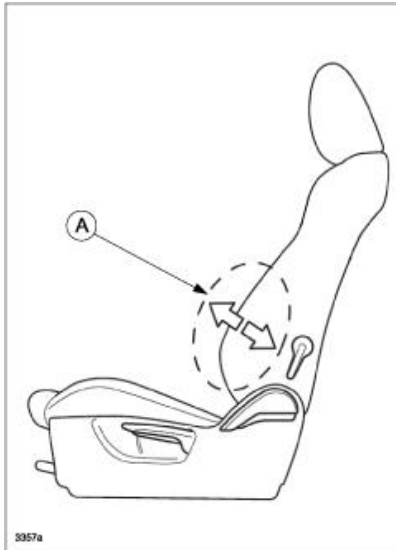
Some vehicles may exhibit the driver seat manual lumbar support adjustment (A) inoperative.

Customers having this concern should have their vehicle repaired using the following repair procedure.

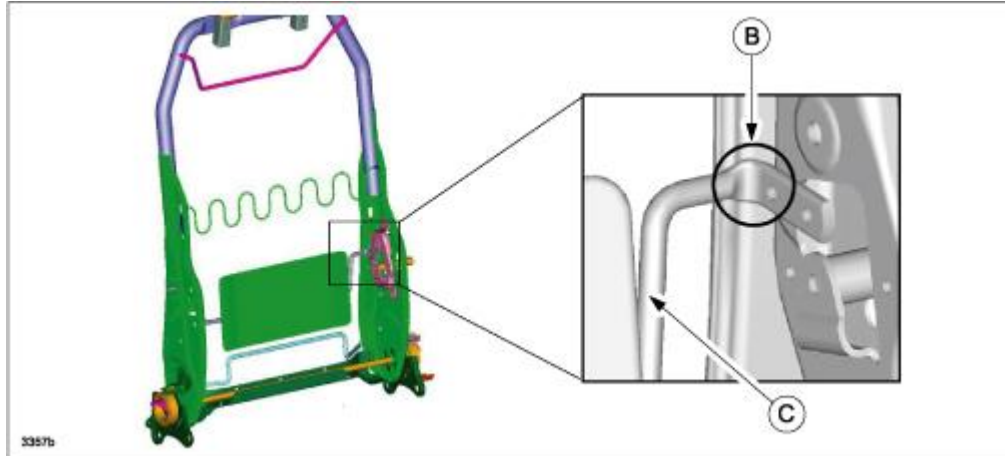
This may be caused by repeated stress to the lumbar support lever (C) at location (B).
