Technical Service Bulletin

09-016/17 - SEAT WARMER MALFUNCTION (CLOTH SEATS ONLY)

Bulletin No.: 09-016/17

2013-2016 CX-5 vehicles equipped with cloth seats.

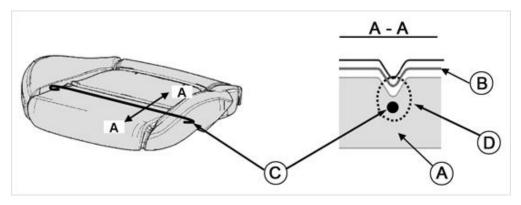
Some vehicles may exhibit the driver and/or front passenger side seat warmer(s) malfunction on any mode (High, Mid and Low). This may be caused by repeated load applied to the seat cushion (A) while the seat is occupied. A section of the heater mat (B) just above the reinforcement rod (C) in the cushion pad (A) contacts internal heater mat wire and causes damage (D).

- 1. Verify the seat warmer is inoperative.
- 2. Replace the seat cushion pad(s). Refer to the MGSS online instructionsFRONT SEAT CUSHION TRIM REMOVAL/INSTALLATION.

NOTE: A new seat cushion pad is available with repositioned internal heater mat wire to prevent contact with reinforcement rod.
