Technical Service Bulletin

Subject: 07-005/17 - POOR AIR CONDITIONING PERFORMANCE AND OPERATION	Bulletin No.: 07-005/17
	Last Issued: 06/30/2017

2016-2017 CX-9 vehicles with VINs lower than **JM3TC*****142099** (produced before May 19, 2017)

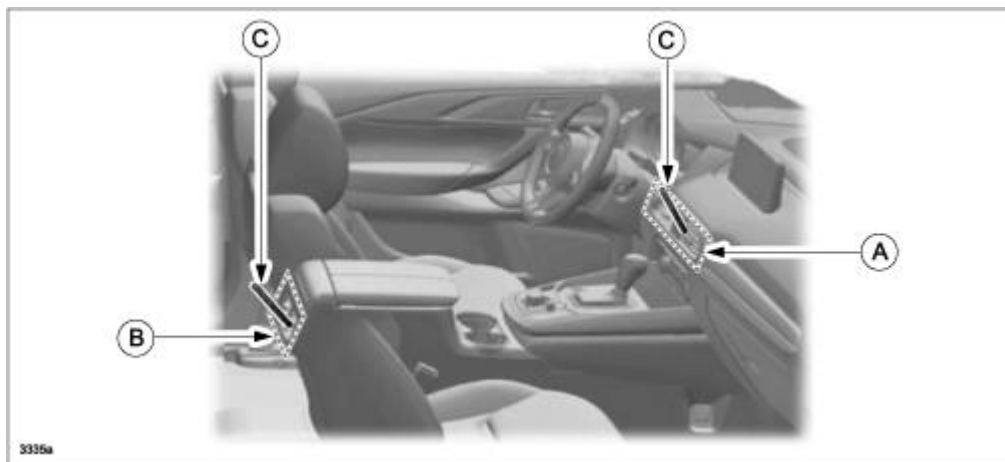
3. Measure the air conditioner output temperature from the passenger's side center ventilator (A) and rear ventilator (B) outlets according to the instructions on MGSS online (REFRIGERANT SYSTEM PERFORMANCE TEST). Record the output temperature values with a dry-bulb thermometer (C) and the ambient temperature when it is measured.
