Technical Service Bulletin

09-029/17 TACHOMETER DISPLAY IN ACTIVE DRIVING DISPLAY
CANNOT BE TURNED OFF

Bulletin No.: 09-029/17

APPLICABLE MODELS/VINS 2016 CX-9

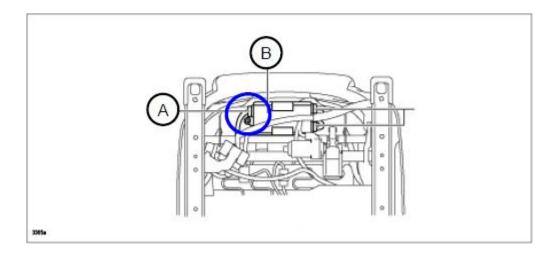
Some customers may complain that the tachometer display in the Active Driving Display cannot be turned off using the MAZDA CONNECT setting menu since it has been removed by a CMU update. The concerns will be noticed after a CMU update from versions 58 to version 59. This is caused by the seat position memory control module storing the active driving display indication position, brightness level, and display information at the same time when the seat position is programmed. If the setting for the tachometer display was left "ON" for the programmed position before the CMU update, the position memory control module still remembers the status and therefore the tachometer display remains.

2. With the ignition switch turned off, disconnect the power supply connector (A) at the position memory control module (B).

- 3. Wait for 10 seconds and re-connect the connector.
- 4. Verify repair and ask the customer to re-program the seat position memory.
