Technical Service Bulletin

Mazda North American Operations Irvine, CA 92618-2922

Bulletin No.: 01-004/17 ENGINE RUNS ROUGH AND CHECK ENGINE LIGHT ON WITH DTCS P0201 AND P0204 OR P0202 AND P0203 Last Issued: 07/05/2017

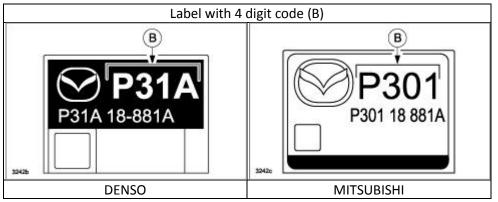
This concern may be caused by an internal failure of the PCM (DENSO produced only). To correct the concern, the PCM internal failure has been eliminated.

2. Check if the PCM is "DENSO" produced. Inspect the PCM label (A) and check the 4-digit code (B) to confirm this code matches with the first 4 digits of DENSO PRODUCED PCM part numbers specified in the GEPC.

- CX-5: PCM REMOVAL/INSTALLATION [SKYACTIV-G 2.0, SKYACTIV-G 2.5]
- Mazda3: PCM REMOVAL/INSTALLATION [SKYACTIV-G 2.0, SKYACTIV-G 2.5]
- Mazda6: PCM REMOVAL/INSTALLATION [SKYACTIV-G 2.5]
- If the PCM is "DENSO", replace the PCM according to the instructions on MS3 online.
