Subject: CONVERTIBLE TOP TENSION BAND(S) DETACHED FROM HEADER PANEL AND HANGING DOWN	Bulletin No.: 09-031/17
	Last Issued: 07/05/2017

2016-2017 MX-5 vehicles with VINs lower than JM1ND****H*121455 (produced before September 23, 2016)

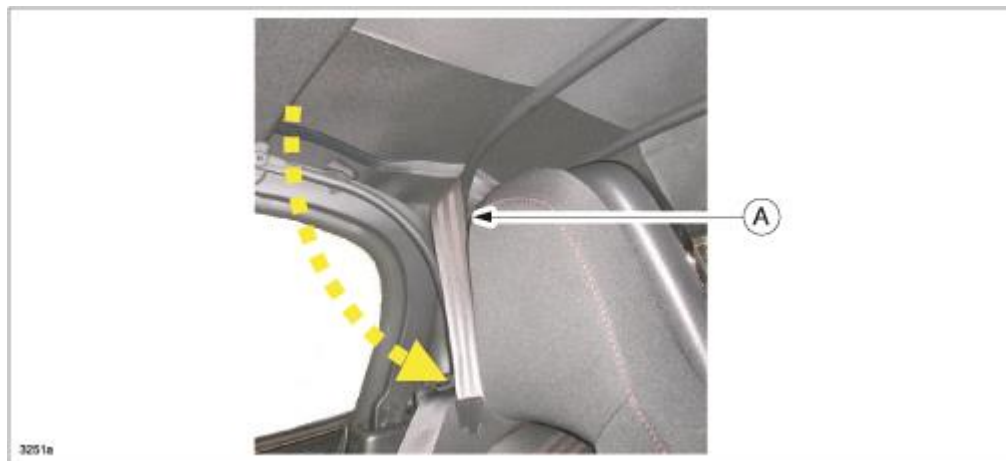
Some vehicles may exhibit the driver and/or passenger side tension band(s) (A) hanging down from the convertible top.

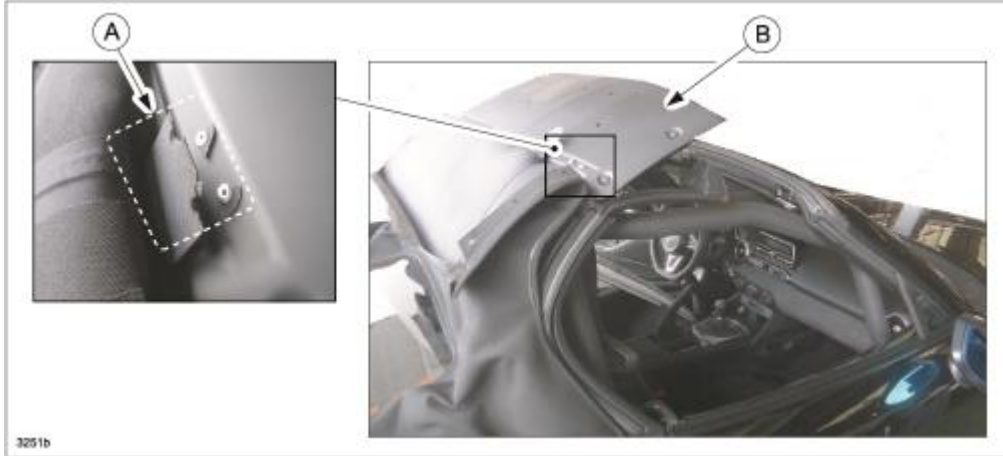
Upon inspection, the plastic plate (A) of tension band is broken where it is riveted to the header panel (B). This is caused by insufficient strength of the plastic plate. To correct this issue, the configuration of the tension band will be changed to increase the strength.

Customers having this concern should have their vehicle repaired using the following repair procedure.
