Technical Service Bulletin

Mazda North American Operations Irvine, CA 92618-2922

HARD SHIFTING/SHIFT LEVER VIBRATION

Bulletin No.: 05-002/17

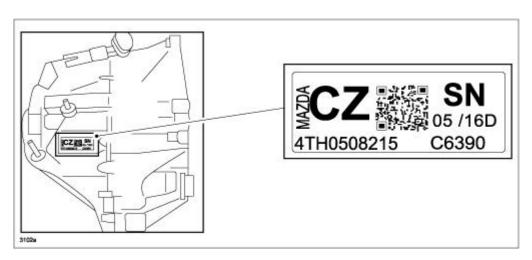
NOTE: The modification(s) applied to the transmission can also be found from the transmission number. The transmission number is printed on the label attached on the top side of the transaxle case. Refer to the below table for the beginning transmission numbers of each modification.

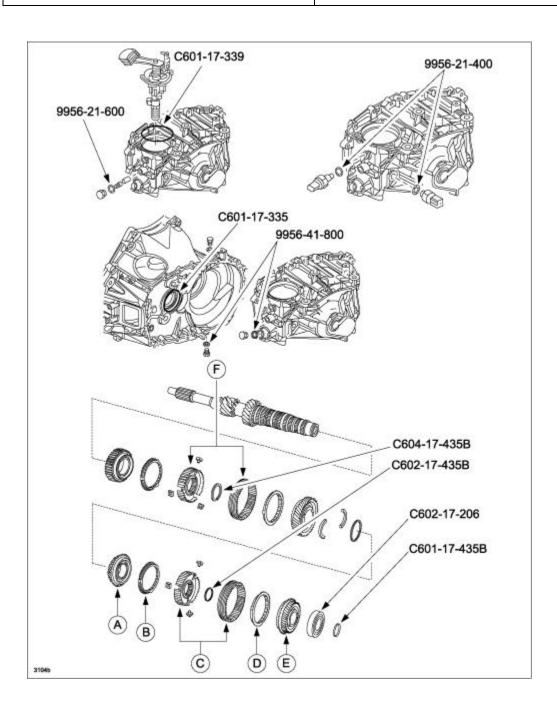
Location of Transmission Related Parts

A: 3rd Gear

B: 3rd Synchronizer Ring

C: 3/4 Clutch Hub Assembly

D: 4th Synchronizer Ring

E: 4th Gear

F: 5/6 Clutch Hub Assembly

- 1. Verify customer concern.
- 2. Remove the transaxle. Refer to MGSS online instructions or the Workshop Manual section 05-15.
- 3. Replace the specified parts in the below tables with modified ones according to the verified symptom(s) and the VIN in the repair. Refer to the C66M-R 6-speed SKYACTIV Manual Transaxle Workshop Manual.
