Technical Service Bulletin

Mazda North American Operations
Irvine, CA 92618-2922

Subject: ROUGH IDLE WITH CHECK ENGINE LIGHT ON AND DTC P0015 / P0524	Bulletin No.: 01-008/17
	Last Issued: 07/24/2017

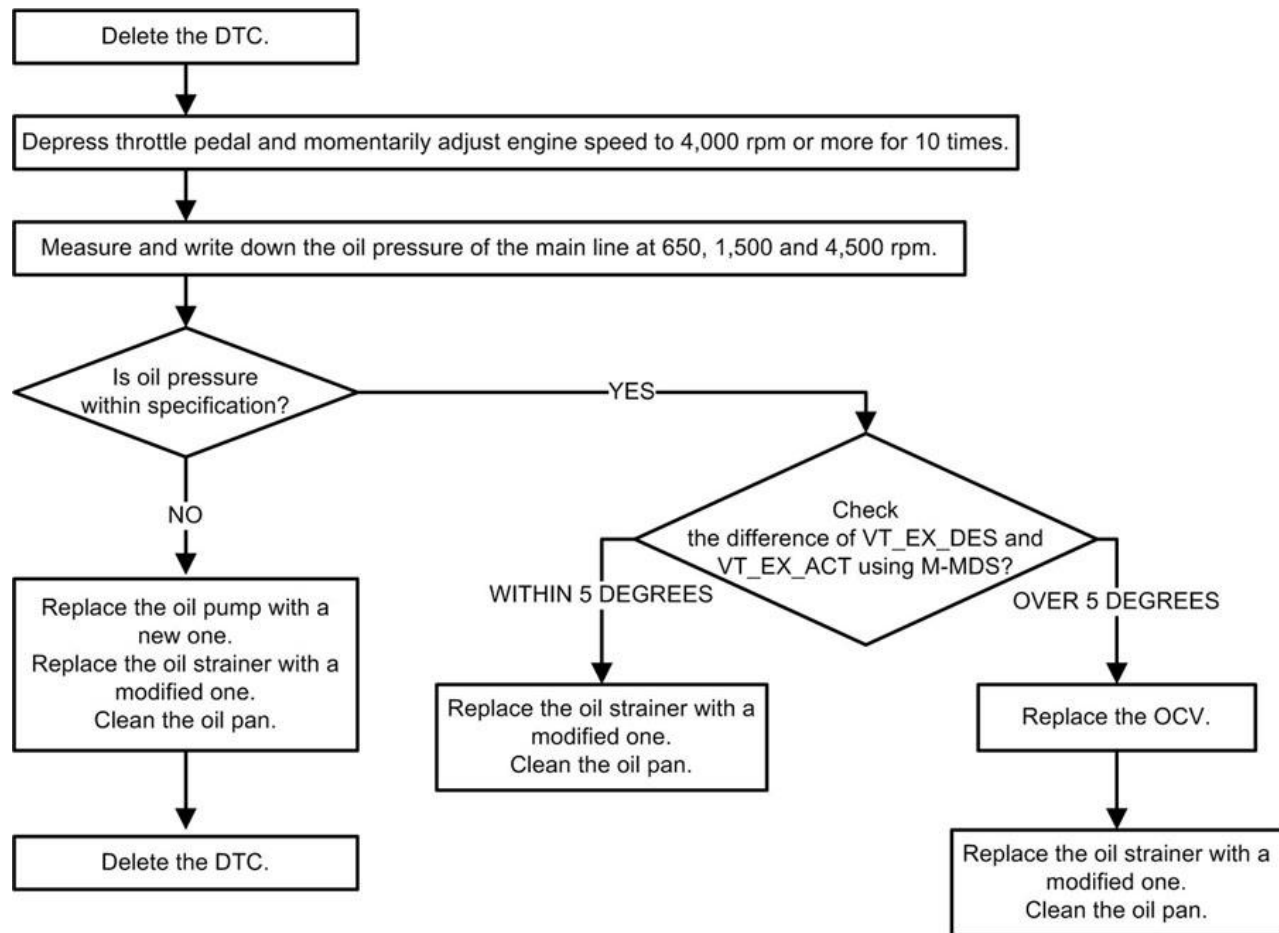
Only P0015 is stored:

This is caused by a drop in engine oil pressure due to a piece of foreign object stuck on the oil pump pressure relief valve or oil control valve (OCV). The temporary entry of the foreign object triggers a check engine light on, but rough idle will not be produced until a later time.

2. Delete the DTC.
3. Depress the throttle pedal and momentarily adjust the engine speed to 4,000 rpm or more for 10 times.
4. Measure the main line oil pressure at 650 rpm, 1,500 rpm and 4,500 rpm according to the instructions on MGSS (OIL PRESSURE INSPECTION).

1) Replace the oil pump with a new one and replace the oil strainer with a modified one according to the instructions on MGSS (OIL PAN REMOVAL/INSTALLATION [SKYACTIV-G 2.0, SKYACTIV-G 2.5]).

- a) Replace the oil strainer with a modified one.
- b) Clean the bottom of the oil pan with a clean cloth.
- c) Replace the engine oil.

- Replace the oil control valve (OCV).
- Replace the oil strainer with a modified one.
- Clean the bottom of the oil pan with a clean cloth.
- Replace the engine oil.
