Technical Service Bulletin

BSM OFF INDICATOR ON WITH DTC U1A4B:97 OR U3000:97

Bulletin No.: 15-001/17

Last Issued: 09/01/2017

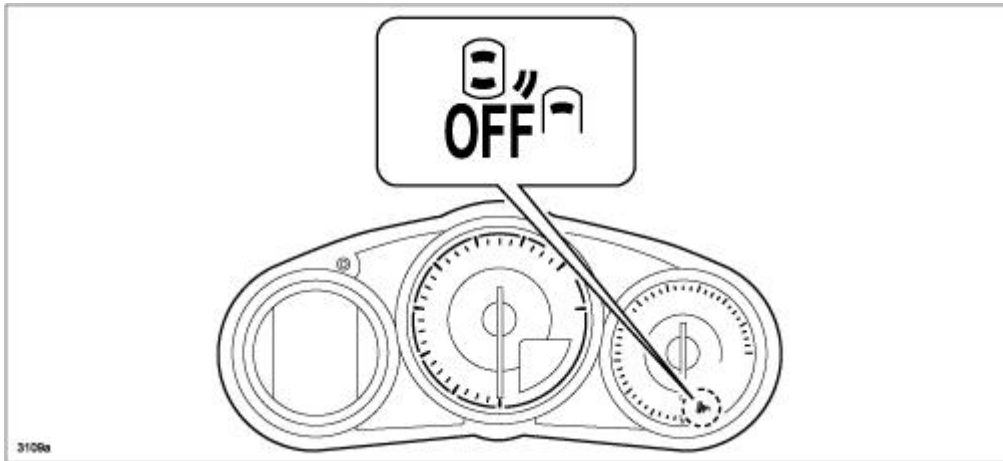
- The BSM turns “OFF” and the BSM OFF indicator turns “ON” in the instrument cluster while driving
- The BSM will not turn on again during the drive cycle
- After cycling the ignition switch off and on again, the BSM operates normally
- DTC U1A4B:97 or U3000:97 is stored in memory

To correct this problem, the control logic of the BSM control modules has been changed.
