Technical Service Bulletin

PAINT RUST/BLISTER ON VERTICAL SURFACE OF TRUNK LID

Bulletin No.: 09-039/17

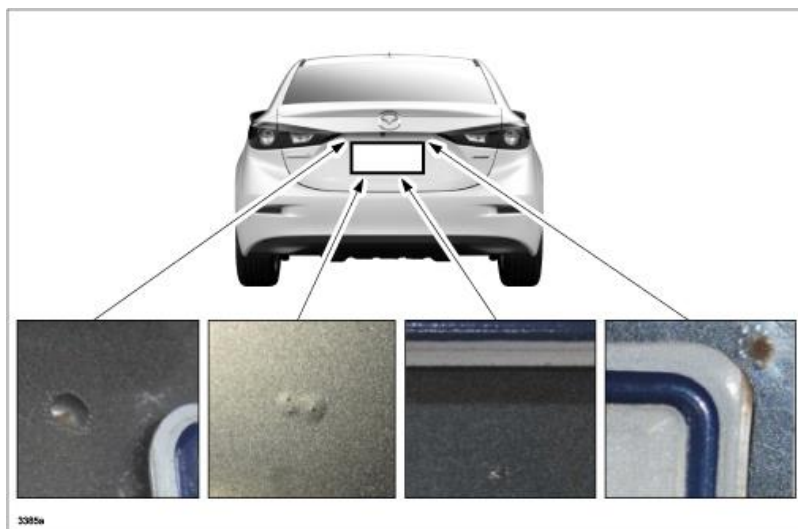
Location and Damage Samples

Some vehicles may exhibit paint rust/blister on the vertical surface of the trunk lid. This is caused by silica contained in snow-melting agents adhering to the trunk lid. To correct this issue, the thickness of the clear coat has been increased.

1. Verify customer concern.
2. Repair the rust damage on the panel.
3. Verify repair.
