Field campaign

| Topic | Convertible Roof System - Oversize Rivet Hole (SC12/13) |
| Campaign number | E773 |

13MY New Continental GTC

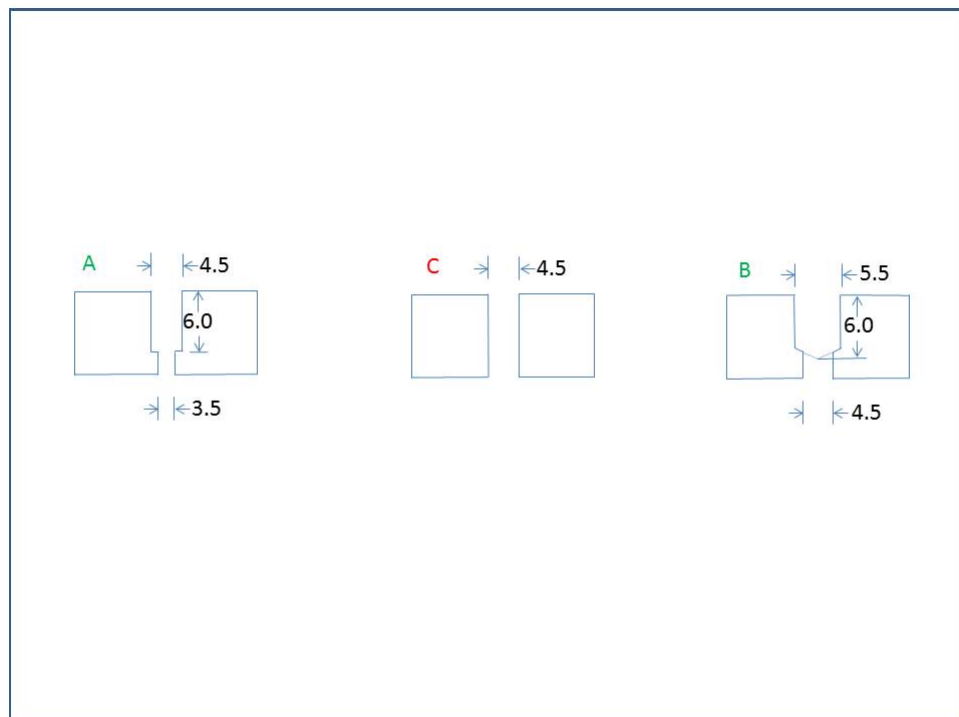
Figure 2

A counter bore operation on the left hand twin bow may have been performed incorrectly resulting in an oversize rivet hole and no counter bore. The counter bore is required to enable the rivet to expand and lock into the casting. This rivet hole requires inspection and if found to be oversize the attached rectification measure performed

If the rivet hole is found to be standard dimensions (diagram A) then fit a replacement standard rivet. On vehicles where the rivet hole is found to be oversize, that is the counter bore dimension has been drilled all the way through leaving no counter bore (diagram C), then a new larger counter bore has to be drilled, 5.5mm, to produce diagram B and the larger rivet used.

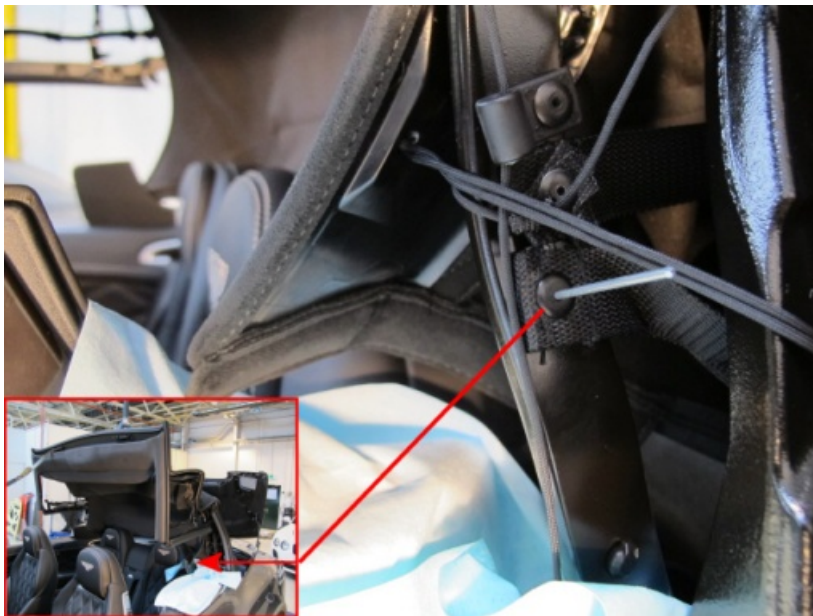
Figure 3

**Note:** Only check and if necessary repair the rivet on the left hand twin bow as shown in figure 3. There are no known issues with the similar rivet on the right hand twin bow

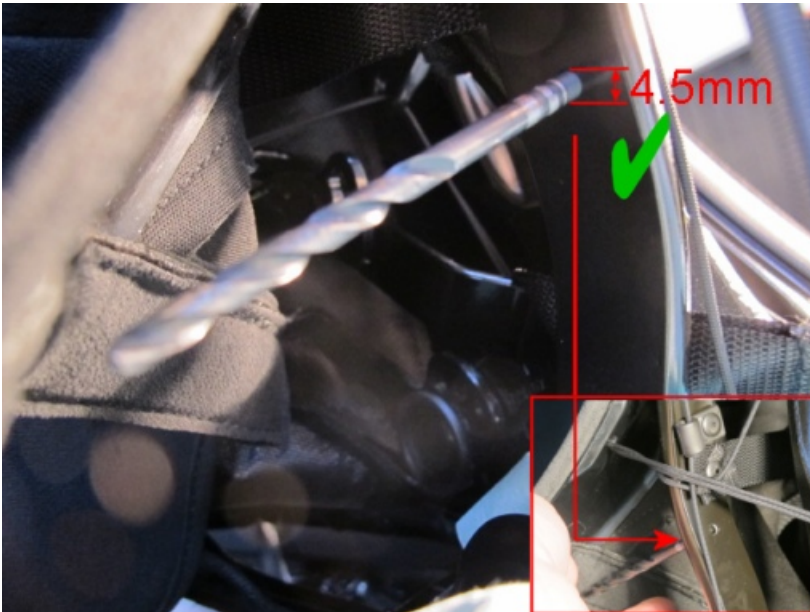
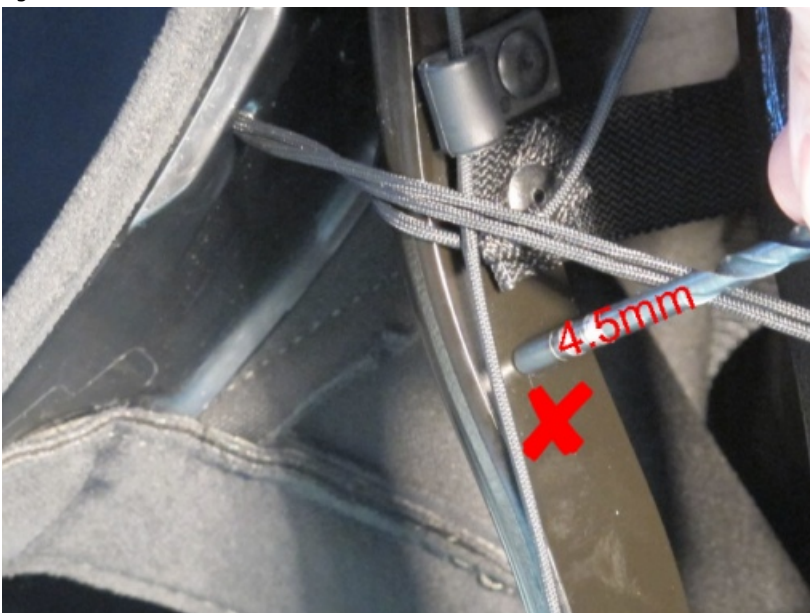
4. Referencing figure 2A use a 4.5mm drill to gauge the size of hole, the 4.5mm drill should enter the 4.5mm bore from the rear (see Figure 5) but not enter the front of the bore indicating that the front part of the bore is the correct size at 3.5mm (see Figure 6). If this is the case re attach

the strap with a new standard rivet (part 'A' figure 1) and apply a green campaign completion mark to the rear of the bow adjacent to the replaced rivet. If the drill gauges the hole as 4.5mm at both ends indicating the hole has been counter bored at 4.5mm through its entire length as shown in figure 2 C, then the following rectification measure is required
