## Technical product information

| <b>Topic</b> | Continental Series and Flying Spur HVAC Valve Knock |
| <b>Transaction No.</b> | 2045028/2 |

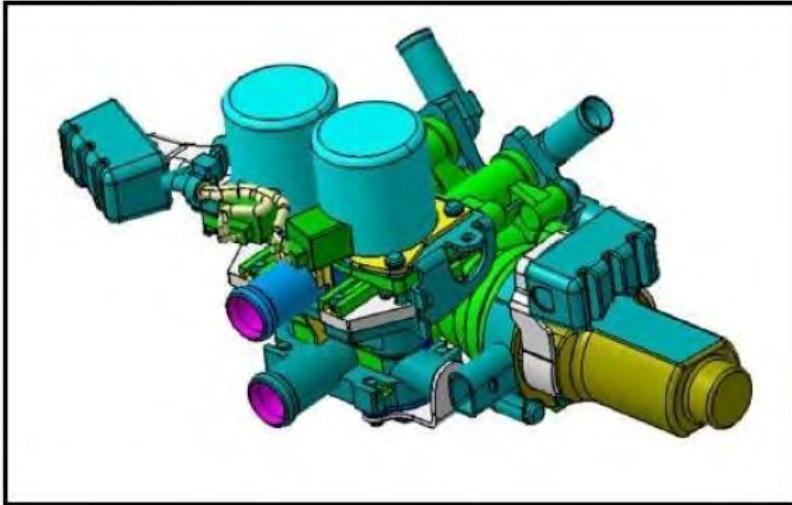
Figure 1

Regular "thud" noise from the Plenum resonating through the vehicle cabin.

The HVAC Water Pump/Valve unit - *Figure 1* - contains two solenoids used to control coolant flow to the heater matrix. During normal operation of the solenoids it may be possible to hear a regular "thud" noise within the vehicle cabin.

With a confirmed complaint of a "thud" noise being generated by the HVAC Water Pump/Valve unit, the link loom 3W0 970 186 - *Figure 2* - should be installed. The link loom consists of two resistors to reduce electrical current to the Water Pump/Valve unit, the solenoids then operate with reduced audible feedback.
