Reference	SSM73473
Models	F-PACE / X761 XE / X760 XF / X260
Title	Click noise from the front of vehicle during steering (with wheels on the ground)
Category	Chassis
Last modified	08-Aug-2017 00:00:00
Symptom	303000 Steering/Handling
Attachments	Nut.jpg (Nut.jpg)

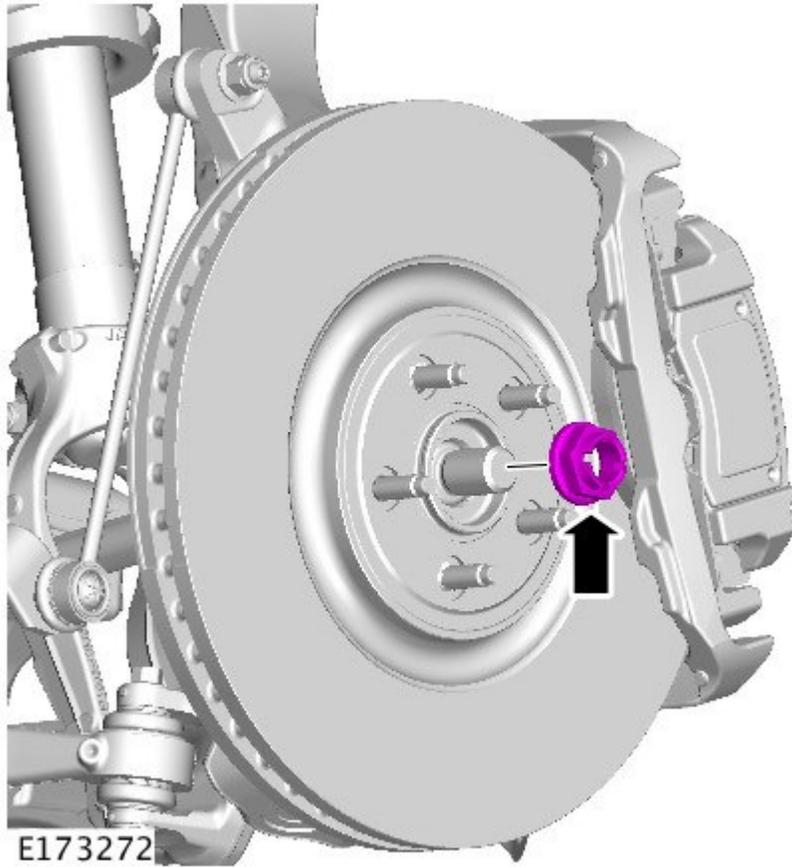
Hub/Knuckle joint not fully consolidated. Attached image shows fixing that is related to this concern.

1. Tighten existing hub nut to 170Nm
2. Remove old hub nut and discard - DO NOT USE Air or Electric tools - remove by hand and use hand tools.
3. Fit new hub nut - DO NOT USE Air or Electric tools.
4. Apply 80Nm Torque.
5. Apply 60° Angle.
