JTB00567NAS1

TECHNICAL BULLETIN

501-02: Front End Body Panels

Creak Noise From Front Bulkhead

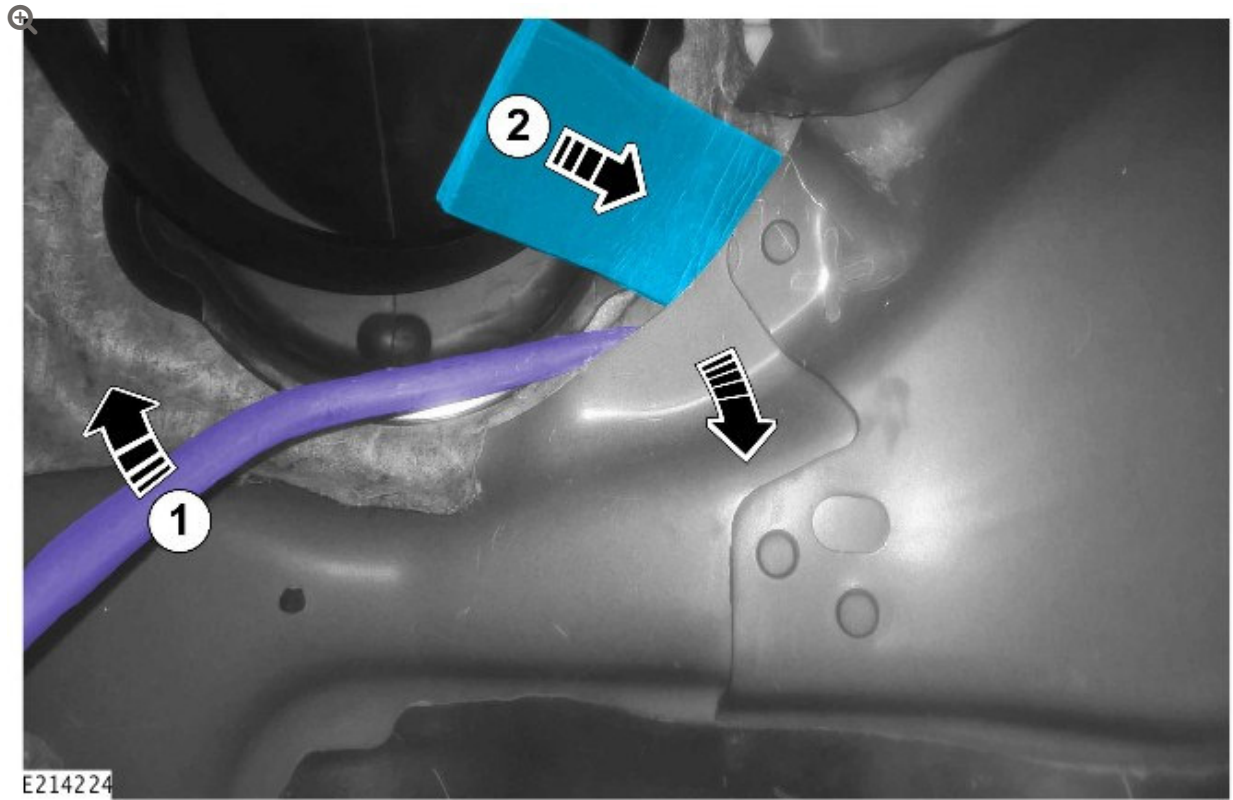
7

A creak noise may be evident from the front bulkhead.

This may be caused by a difference within the structural tolerances of the body panels in the front bulkhead.

Take care to not damage the steering column seal when separating the body panels.

Insert the foam pad as far into the gap between the body panels as possible.

Using a suitable tool, separate the 2 body panels (1) and then install the foam pad (2) as far into the gap as possible.
